# City of Santa Fe

Investment Grade Audit (IGA) Report

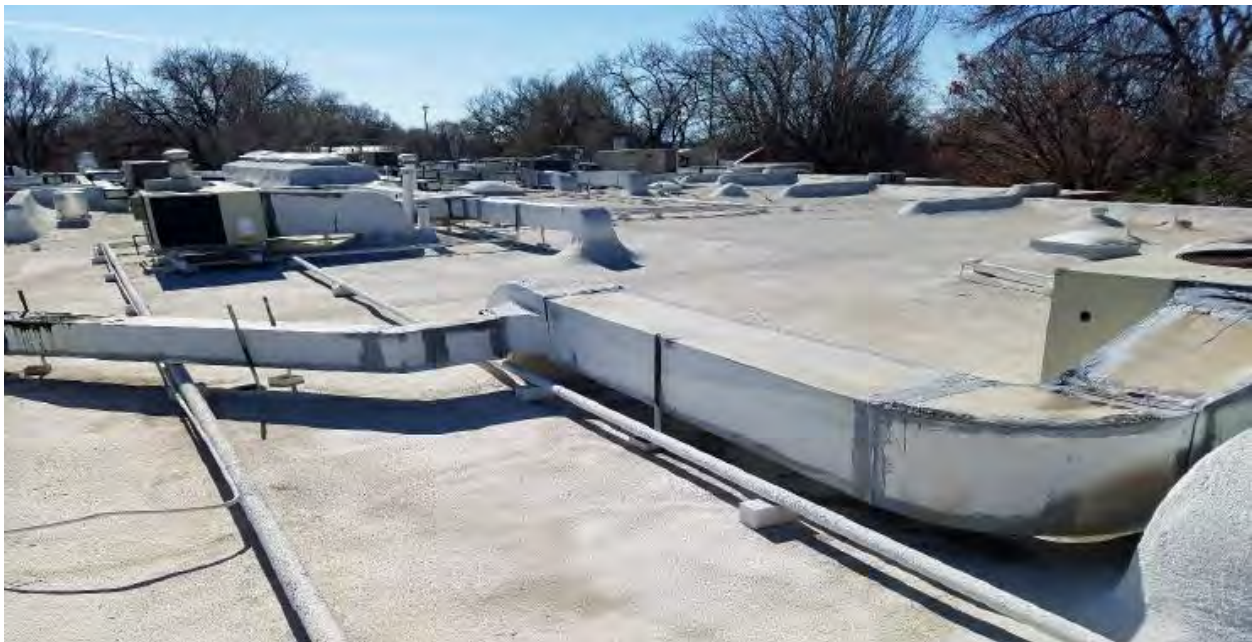
Figure 6: Roof at the Head Start

This building is a single story with an addition that includes a kitchen on the south side. The flat roof is covered with a sprayed-on urethane foam (SPUF) with a roof coating applied over foam and granules broadcast into the coating. According to the principal, this system was applied around five years ago. This roof structure is likely a metal deck supported by steel joist. Large cracks and punctures are allowing water into the roof system.

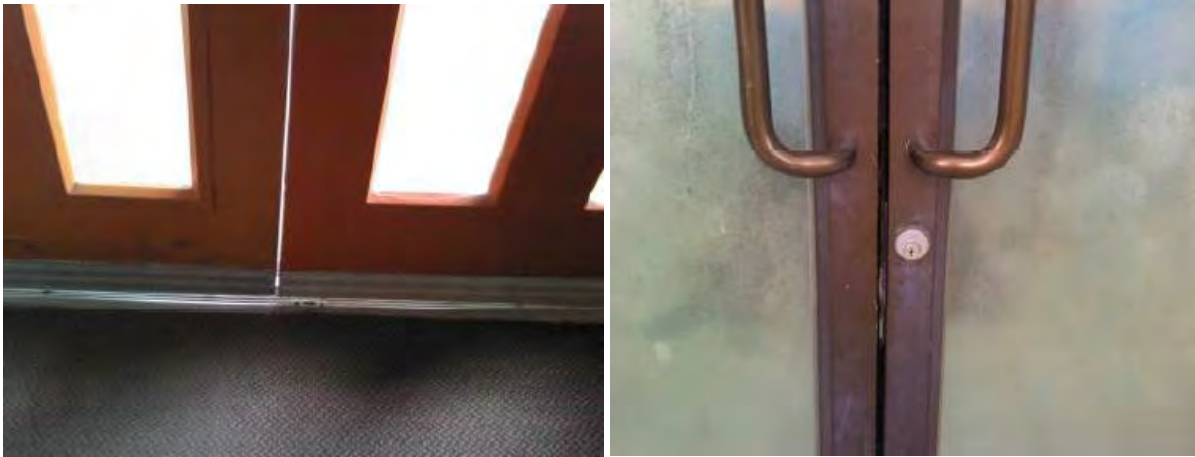
Figure 7: Gaps in building envelope at Alto Complex

The exterior walls are most likely constructed with 2"x6" wood studs at 16" on center, filled with batt insulation. The exterior of the original building has a white brick veneer and tan stucco on the addition. Most windows throughout the building are double paned with vinyl exterior and wood frame on the exterior and interior. There are a handful of skylights that are 2'x2' and 2'x4'. The largest area of infiltration/exfiltration is at the doors on all sides of the building. These doors would benefit from new weather-strip and door sweeps that would reduce energy consumption. Several penetrations and

openings are located around the perimeter walls and sealing these would reduce air infiltration/exfiltration and energy loss. We also recommend sealing approximately 40 feet of wall cracks.

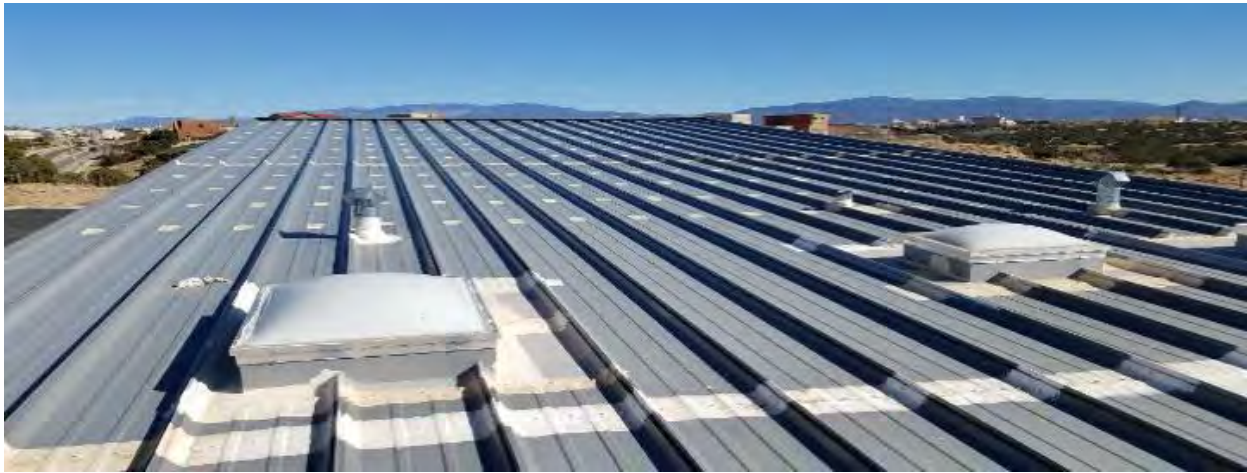
Figure 9: Fire Station #8 Roof

are fastened through the panels into the purlins. The exposed fasteners, curbs, roof penetrations, and horizontal seams have been sealed with an unknown coating that appears to be in good condition.

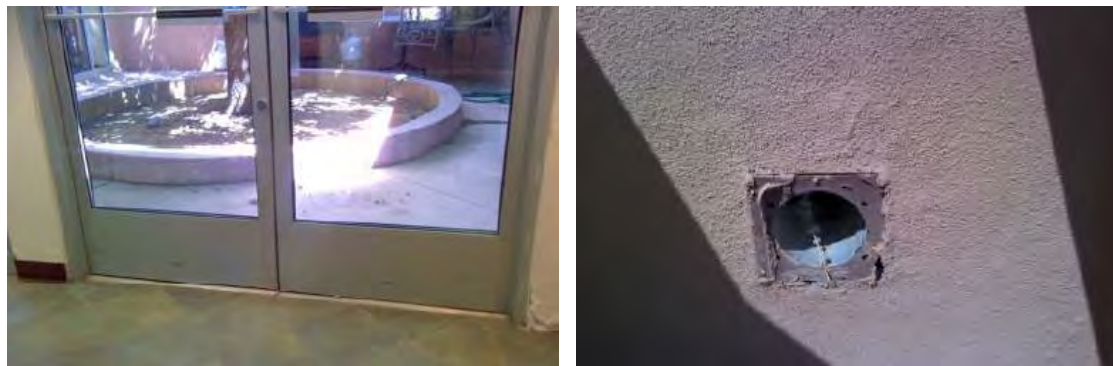
Figure 13: Gaps and openings in building envelope at the Fort Marcy Recreation Complex

or metal. The largest area of infiltration/exfiltration is at the doors on all sides of the building. These doors would benefit from new weather-strip and door sweeps that would reduce energy consumption. Several penetrations and blank openings are located around the perimeter walls and sealing these would reduce air infiltration/exfiltration and energy loss.

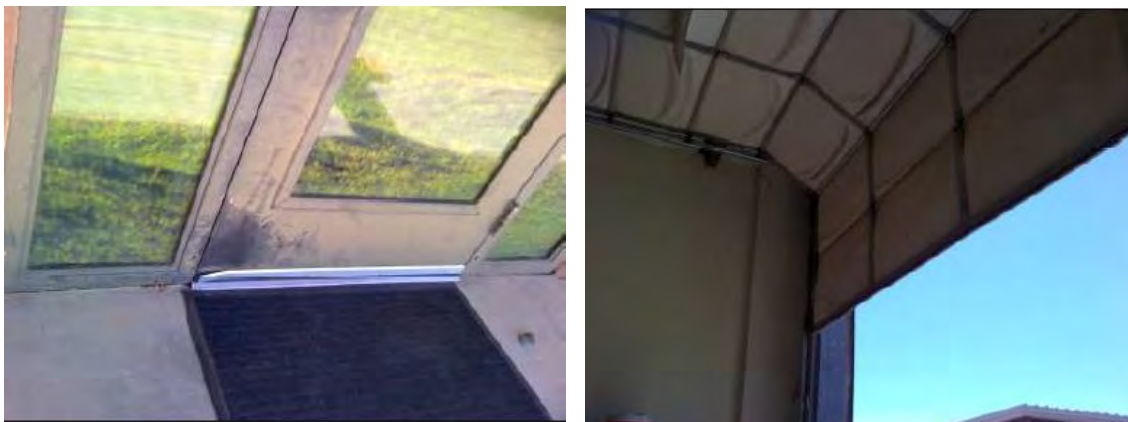
Figure 21: MRC building envelope issues

The largest area of infiltration/exfiltration is at the doors on all sides of the building. These doors would benefit from new weather-strip and door sweeps that would reduce energy consumption. Several penetrations and blank openings are located around the perimeter walls and sealing these would reduce air infiltration/exfiltration and energy loss.

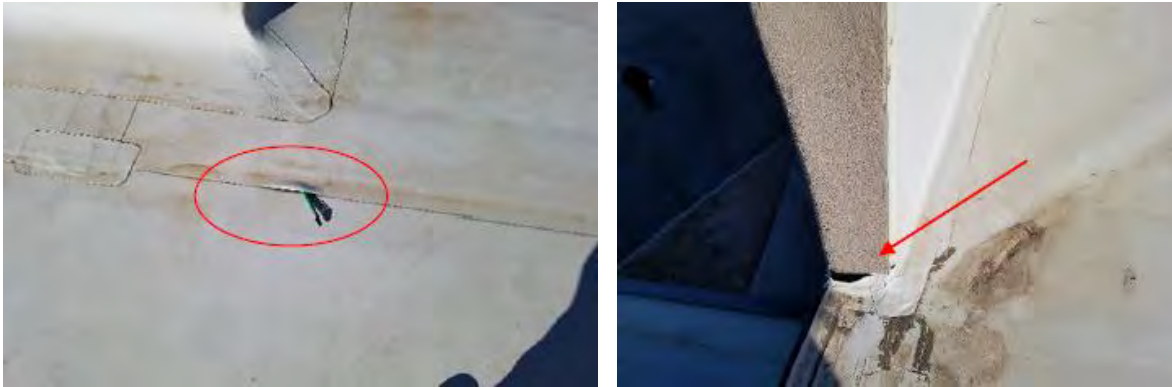
Figure 23: Building envelope issues at the Police Department Administration building roof

The flat roof is supported by metal deck over steel joist and has batt insulation in the ceiling space. The original building was re-roofed in 2009 with a Tremco TPA membrane. In consultations with the manufacturer, the roof is under warranty and Tremco is recommending performing repairs on several locations where seams require re-welding and installing terminal bars are required. The building addition roof has a 60 mil TPO adhered system.

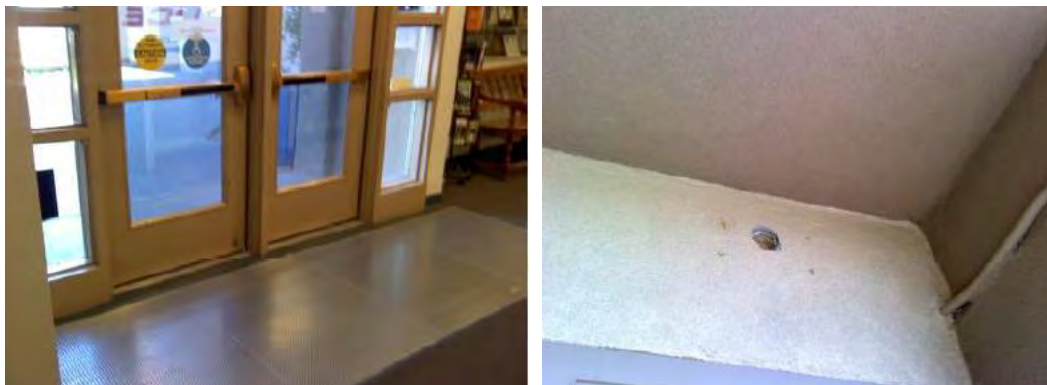
Figure 24: Building envelope gaps at the Police Department Administration building

The exterior walls are metal studs at 16" on center, filled with batt insulation, a stucco exterior, and sheetrock interior. The majority of windows throughout the building are double paned with steel or aluminum frames. The main entrance on the west side of the building is through a set of metal double doors with large glass sections. Auxiliary entrances located around the building are single doors made of wood or metal. The largest area of infiltration/exfiltration is at the doors on all sides of the building. These doors would benefit from new weather-strip and door sweeps that would reduce energy consumption. Several penetrations and blank openings are located around the perimeter walls and sealing these would reduce air infiltration/exfiltration and energy loss.

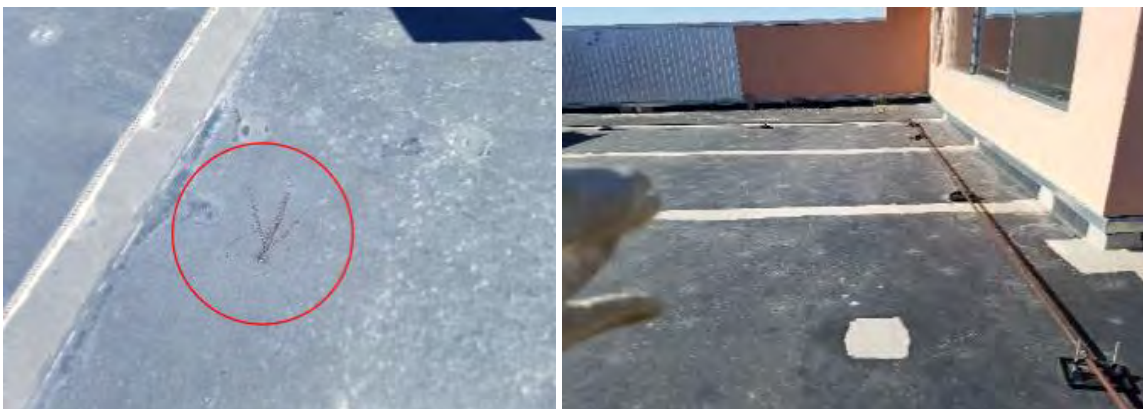
Figure 29: Southside Library Roofing Condition and Blemishes

There are two types of a roof on this building. Firstly, a flat built-up roof that covers the majority of the roof with a 60-mil adhered EPDM roof system supported by metal deck and steel joist. There are multiple punctures in the membrane and deteriorating patches with unknown material. It is apparent with the amount of patchwork present that the library has experienced leaks. These repairs have most likely voided the original manufacturer warranty. The second is a sloped corrugated metal roof, located above the entrance and portions of the elevated roof in the center of the building.

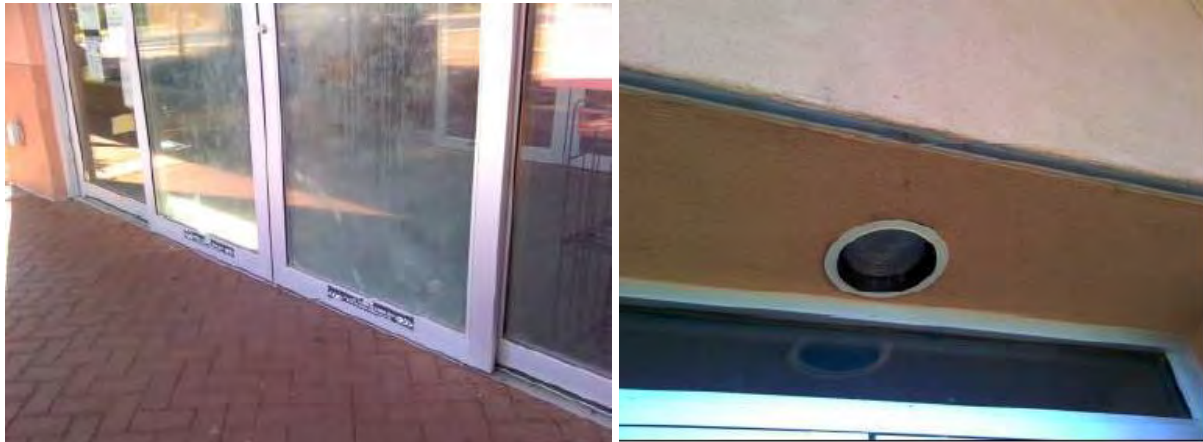
Figure 30: Southside Library Building Envelope Concerns

double paned with a metal frame. The main public entrance is at the north side of the building through a metal-framed door with large window sections. An additional staff door is located on the southeast side. Auxiliary entrances located around the building are single doors made of metal. The largest area of infiltration/exfiltration is at the doors on all sides of the building. These doors would benefit from new weather-strip and door sweeps that would reduce energy consumption. Sealing several penetrations and blank openings along with lighting fixtures located around the perimeter walls would reduce air infiltration/exfiltration and energy loss.

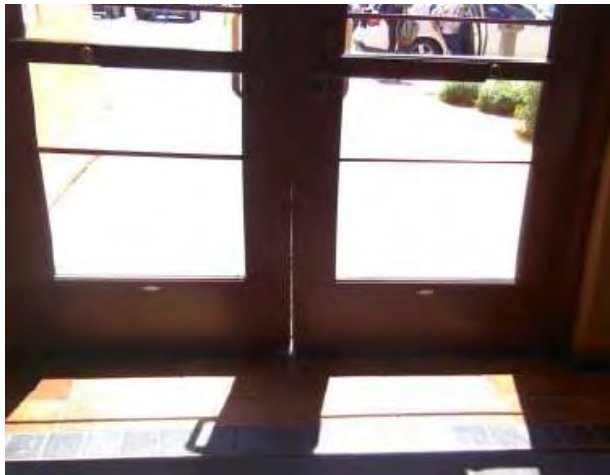
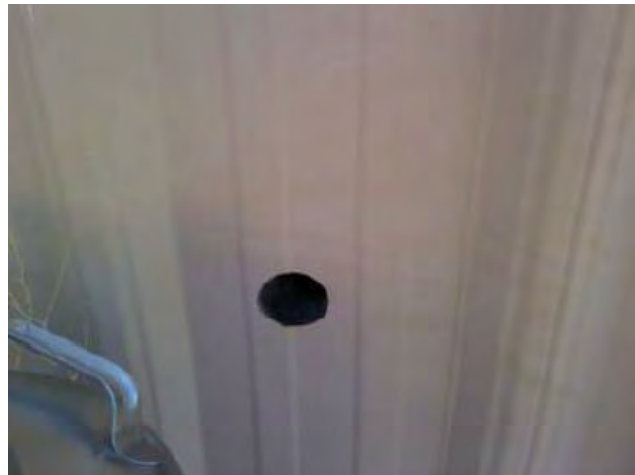
Figure 40: Building Envelope Gaps at the Santa Fe Regional Airport

The roof is supported by steel joist and metal deck above the garage and built-up roof over metal deck above the living area. The exterior walls are most likely 6" metal studs at 16" on center, filled with batt insulation, a stucco exterior, and sheetrock interior. The windows and entrance doors with windows of this building are double paned with metal frame. There three large metal garage roll-up doors on both the north and south of the building where the fire trucks and ambulance are located. The largest area of infiltration/exfiltration is at the doors on all sides of the building. These doors would benefit from new weather-strip and door sweeps that would reduce energy consumption. Several penetrations and blank openings are located around the perimeter walls and sealing these would reduce air infiltration/exfiltration and energy loss.

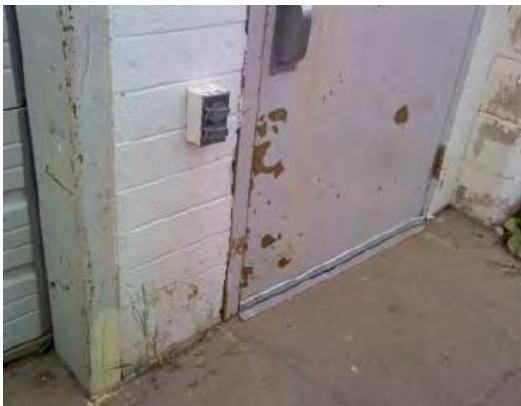
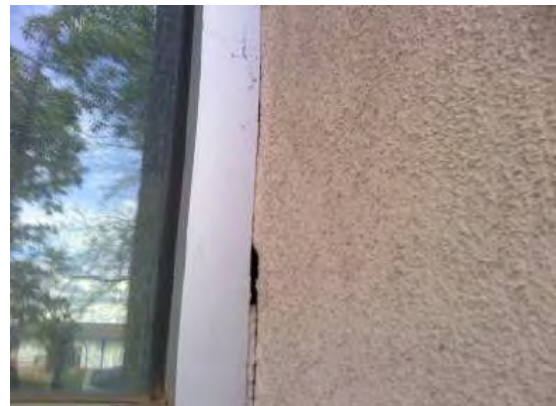
Figure 44: Gaps in Building Envelope at Siler Complex Building C

The exterior office walls have a tan stucco exterior while the taller garage walls are constructed from a light tan metal and furred out sheetrock interior with batt insulation. The majority of windows throughout the building are double paned. Entrance and additional auxiliary doors located around the building are single doors made of wood or metal. There are a number of large metal roll-up doors located at the garage bays. The largest area of infiltration/exfiltration is at the perimeter doors. These doors would benefit from new weather-strip and door sweeps that would reduce energy consumption. Several penetrations and blank openings are located around the perimeter walls and sealing these would reduce air infiltration/exfiltration and energy loss. Several windows on Building A have ineffective sealant and would also benefit from resealing.

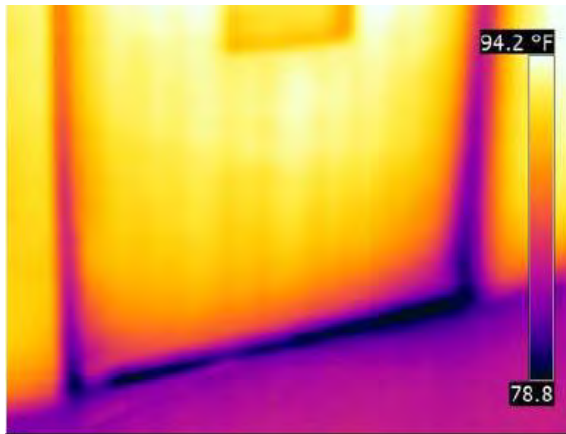
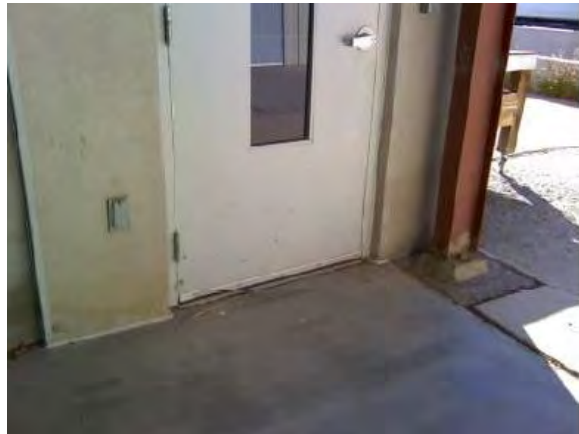
Figure 46: Thermal Imaging of Gaps in Building Envelope at Siringo Complex Warehouse

This building is a premanufactured metal building with a sloped metal roof and sheet metal exterior walls with rolled batt insulation. The largest amount of infiltration/exfiltration on these buildings was at the exterior doors. These doors would benefit from new door sweeps and weather stripping and some would require new sealant around the frame.

Sealing penetrations and blank openings is recommended to reduce air and moisture infiltration leading to reduce energy loss.

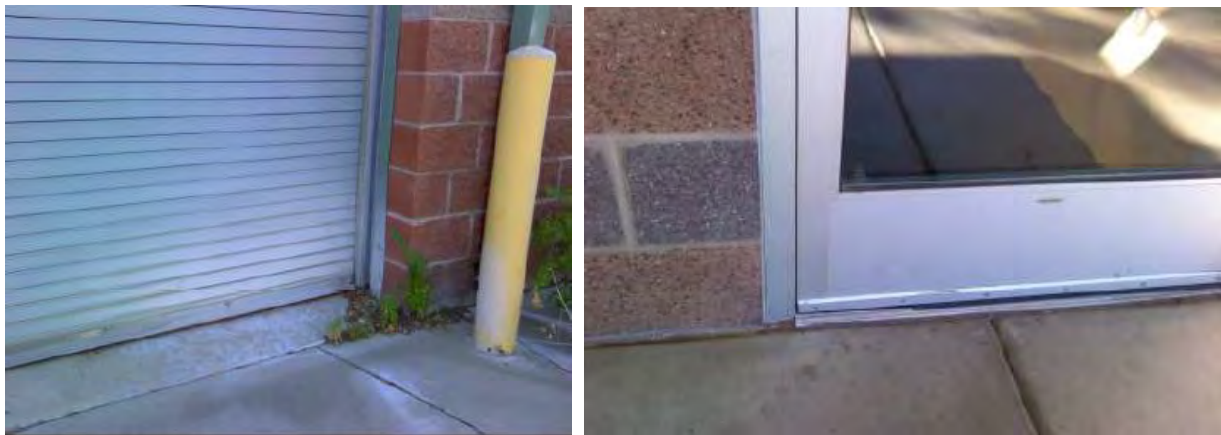
Figure 50: Gaps in Building Envelope at Transit Administration

The largest area of infiltration/exfiltration is at the perimeter doors. These doors would benefit from new weather-strip and door sweeps that would reduce energy consumption. Several penetrations and blank openings are located around the perimeter walls and sealing these would reduce air infiltration/exfiltration and energy loss.

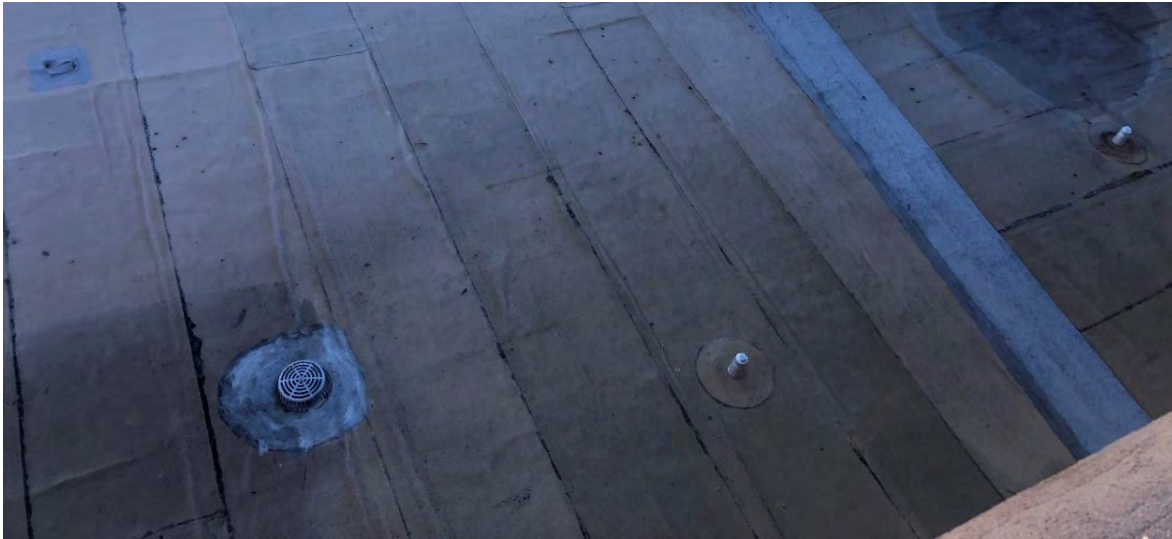
Figure 53: Roof Condition at Canyon Road Water Treatment Plant

The main building at the Canyon Road Water Treatment Plant (WTP) age is unknown but the roof appears to be 15-25 years of age. The facility has a built-up roof system over a concrete deck. Visual inspection and core samples revealed that the existing built up roof system is different for the upper and lower roofs, but is typically constructed from Polyiso, perlite 3-ply BUR, #90 cap sheet and mopped asphalt.
