City of Santa Fe

Investment Grade Audit (IGA) Report

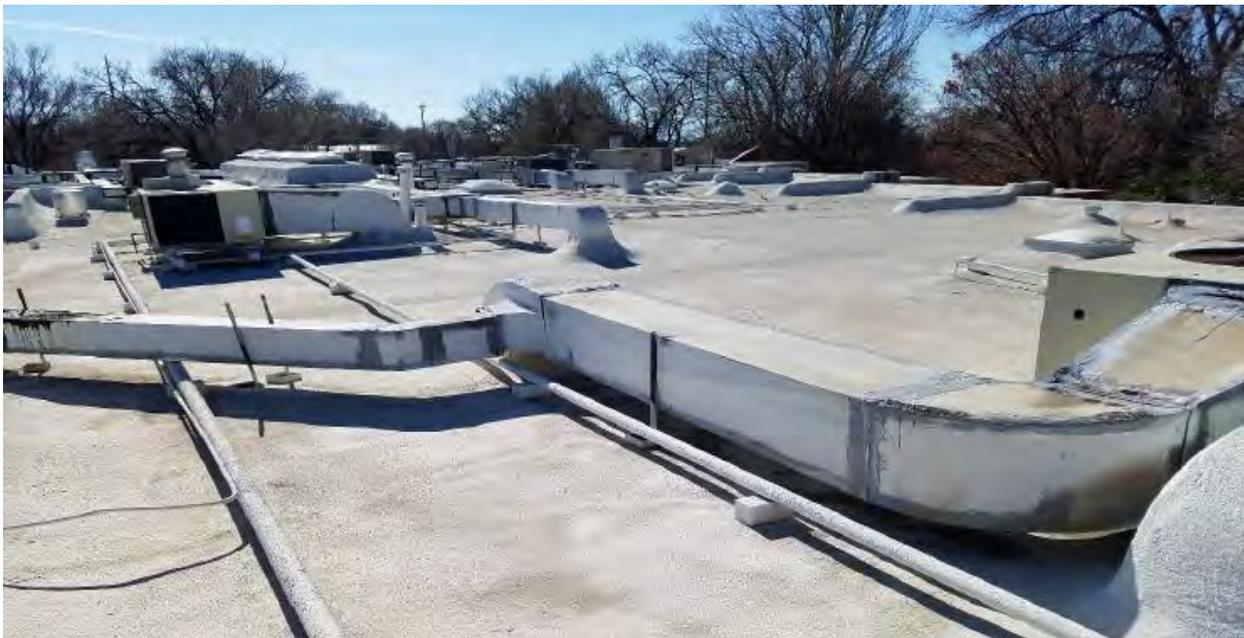
This building is a single story with an addition that includes a kitchen on the south side. The flat roof is covered with a sprayed-on urethane foam (SPUF) with a roof coating applied over foam and granules broadcast into the coating. According to the principal, this system was applied around five years ago. This roof structure is likely a metal deck supported by steel joist. Large cracks and punctures are allowing water into the roof system.

Figure 6: Roof at the Head Start

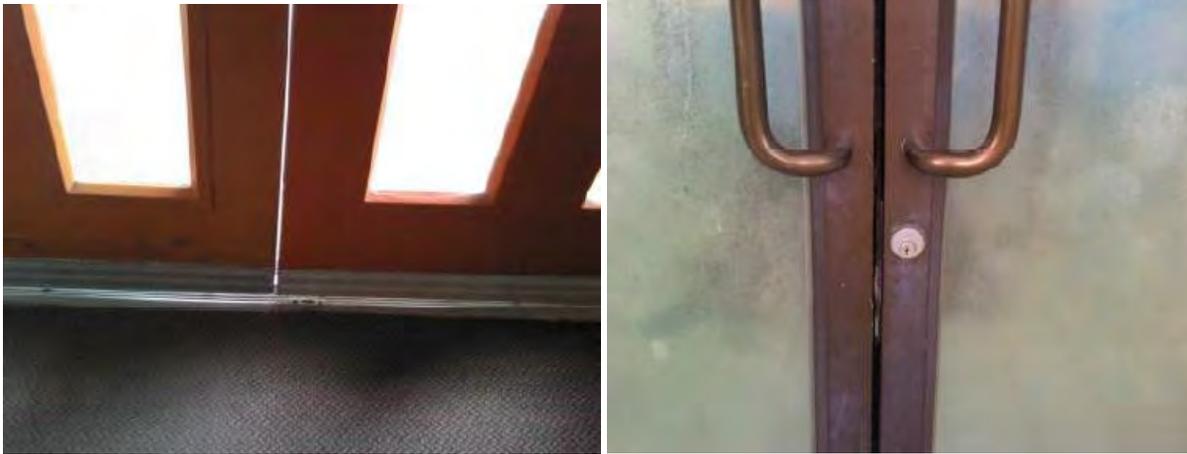
The exterior walls are most likely constructed with 2"x6" wood studs at 16" on center, filled with batt insulation. The exterior of the original building has a white brick veneer and tan stucco on the addition. Most windows throughout the building are double paned with vinyl exterior and wood frame on the exterior and interior. There are a handful of skylights that are 2'x2' and 2'x4'. The largest area of infiltration/exfiltration is at the doors on all sides of the building. These doors would benefit from new weather-strip and door sweeps that would reduce energy consumption. Several penetrations and

Figure 7: Gaps in building envelope at Alto Complex

openings are located around the perimeter walls and sealing these would reduce air infiltration/exfiltration and energy loss. We also recommend sealing approximately 40 feet of wall cracks.

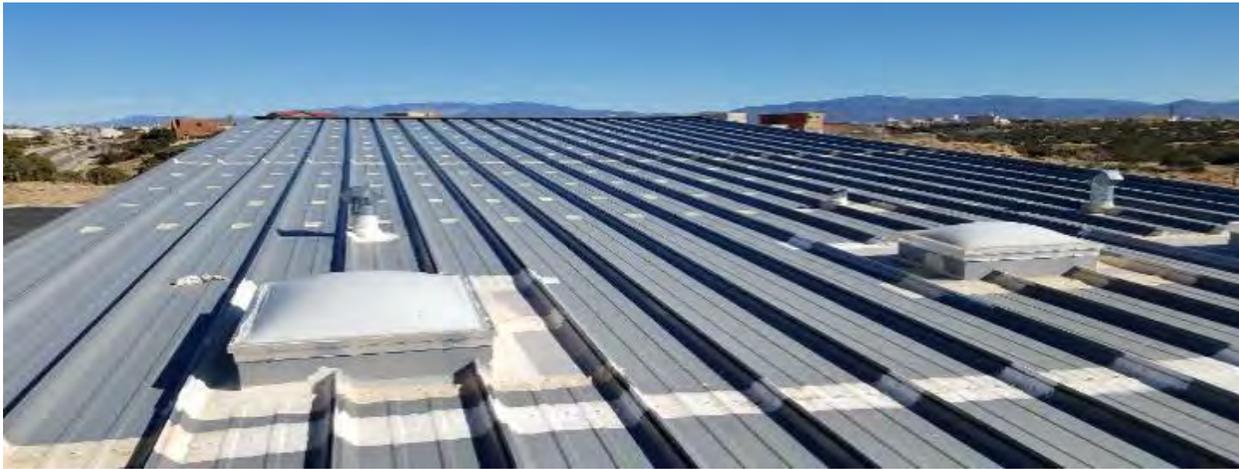
are fastened through the panels into the purlins. The exposed fasteners, curbs, roof penetrations, and horizontal seams have been sealed with an unknown coating that appears to be in good condition.

Figure 9: Fire Station #8 Roof

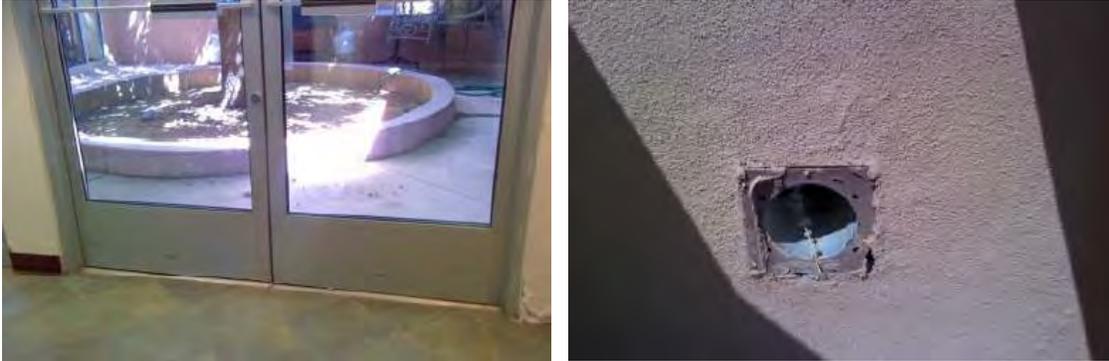
or metal. The largest area of infiltration/exfiltration is at the doors on all sides of the building. These doors would benefit from new weather-strip and door sweeps that would reduce energy consumption. Several penetrations and blank openings are located around the perimeter walls and sealing these would reduce air infiltration/exfiltration and energy loss.

Figure 13: Gaps and openings in building envelope at the Fort Marcy Recreation Complex

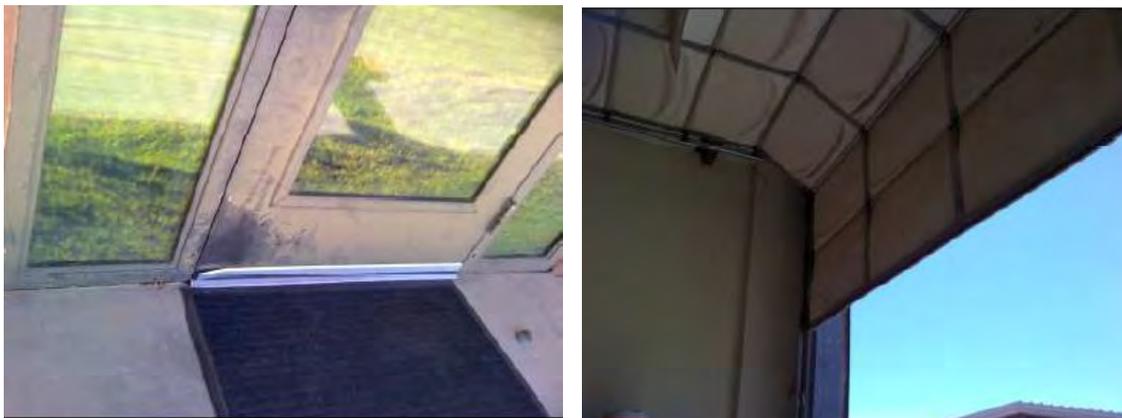
The largest area of infiltration/exfiltration is at the doors on all sides of the building. These doors would benefit from new weather-strip and door sweeps that would reduce energy consumption. Several penetrations and blank openings are located around the perimeter walls and sealing these would reduce air infiltration/exfiltration and energy loss.

Figure 21: MRC building envelope issues

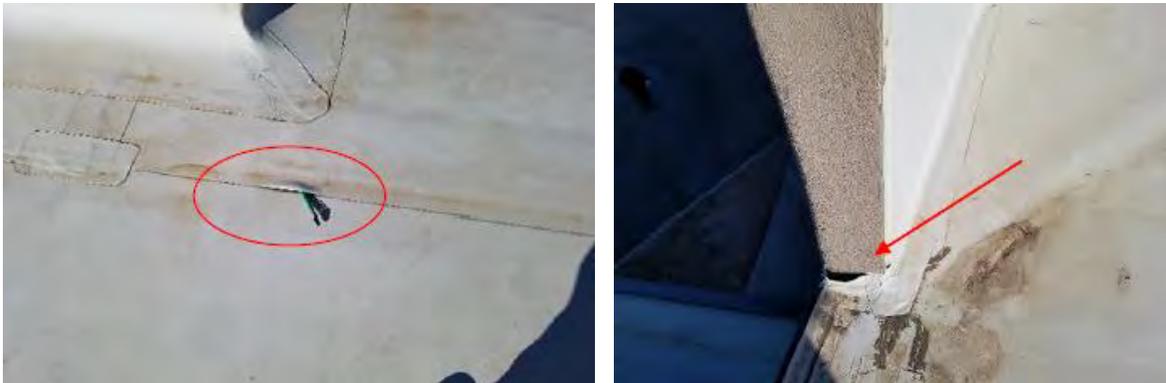
Figure 23: Building envelope issues at the Police Department Administration building roof

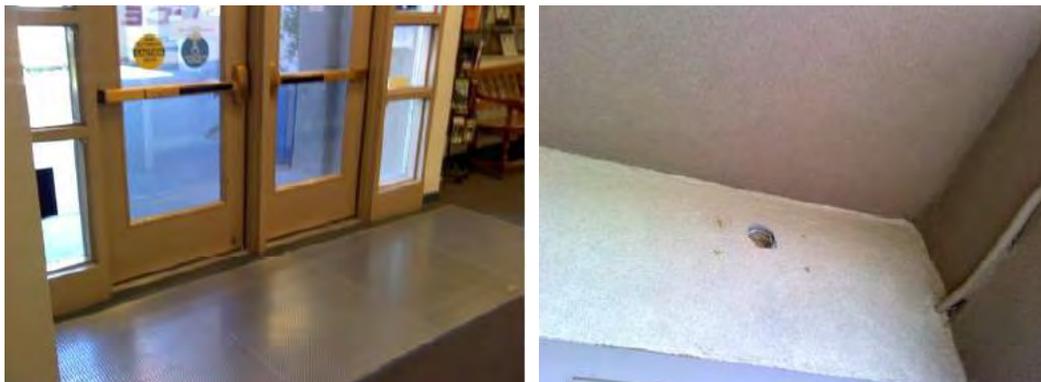
The exterior walls are metal studs at 16" on center, filled with batt insulation, a stucco exterior, and sheetrock interior. The majority of windows throughout the building are double paned with steel or aluminum frames. The main entrance on the west side of the building is through a set of metal double doors with large glass sections. Auxiliary entrances located around the building are single doors made of wood or metal. The largest area of infiltration/exfiltration is at the doors on all sides of the building. These doors would benefit from new weather-strip and door sweeps that would reduce energy consumption. Several penetrations and blank openings are located around the perimeter walls and sealing these would reduce air infiltration/exfiltration and energy loss.

Figure 24: Building envelope gaps at the Police Department Administration building

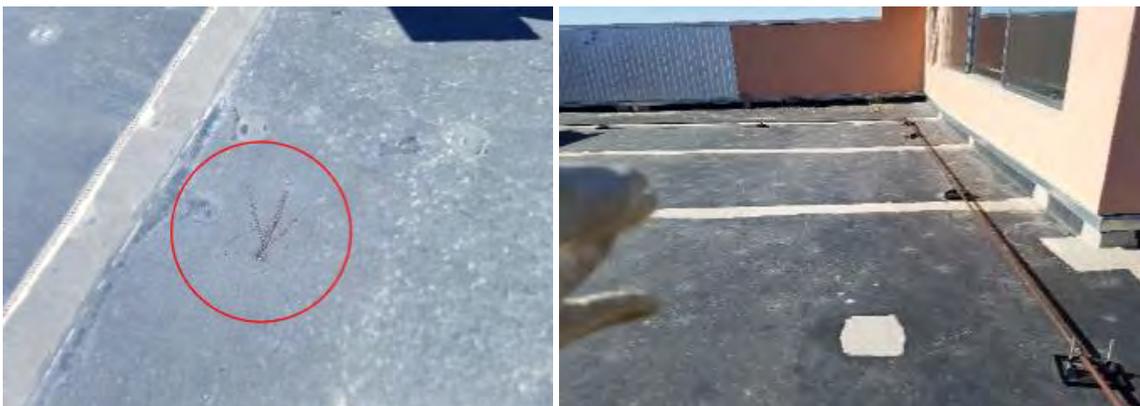
There are two types of a roof on this building. Firstly, a flat built-up roof that covers the majority of the roof with a 60-mil adhered EPDM roof system supported by metal deck and steel joist. There are multiple punctures in the membrane and deteriorating patches with unknown material. It is apparent with the amount of patchwork present that the library has experienced leaks. These repairs have most likely voided the original manufacturer warranty. The second is a sloped corrugated metal roof, located above the entrance and portions of the elevated roof in the center of the building.

Figure 29: Southside Library Roofing Condition and Blemishes

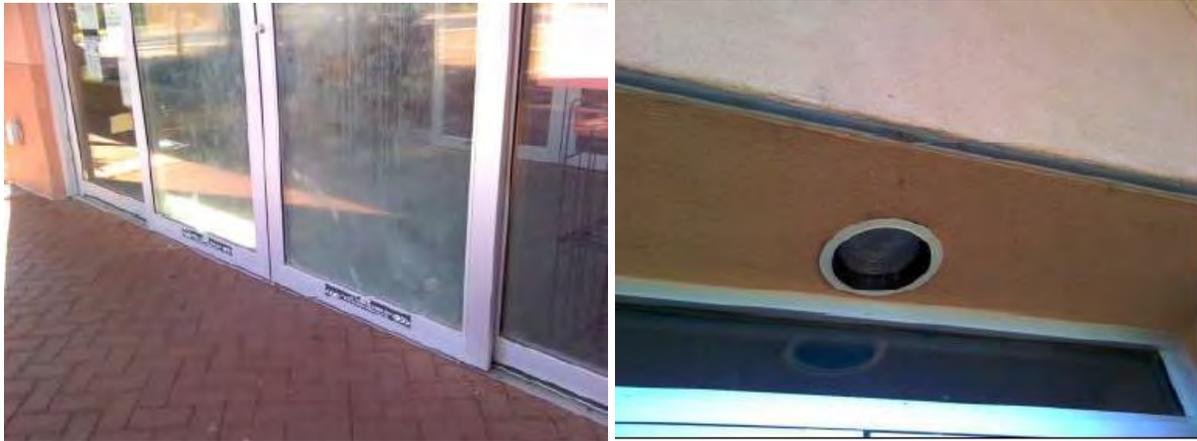
double paned with a metal frame. The main public entrance is at the north side of the building through a metal-framed door with large window sections. An additional staff door is located on the southeast side. Auxiliary entrances located around the building are single doors made of metal. The largest area of infiltration/exfiltration is at the doors on all sides of the building. These doors would benefit from new weather-strip and door sweeps that would reduce energy consumption. Sealing several penetrations and blank openings along with lighting fixtures located around the perimeter walls would reduce air infiltration/exfiltration and energy loss.

Figure 30: Southside Library Building Envelope Concerns

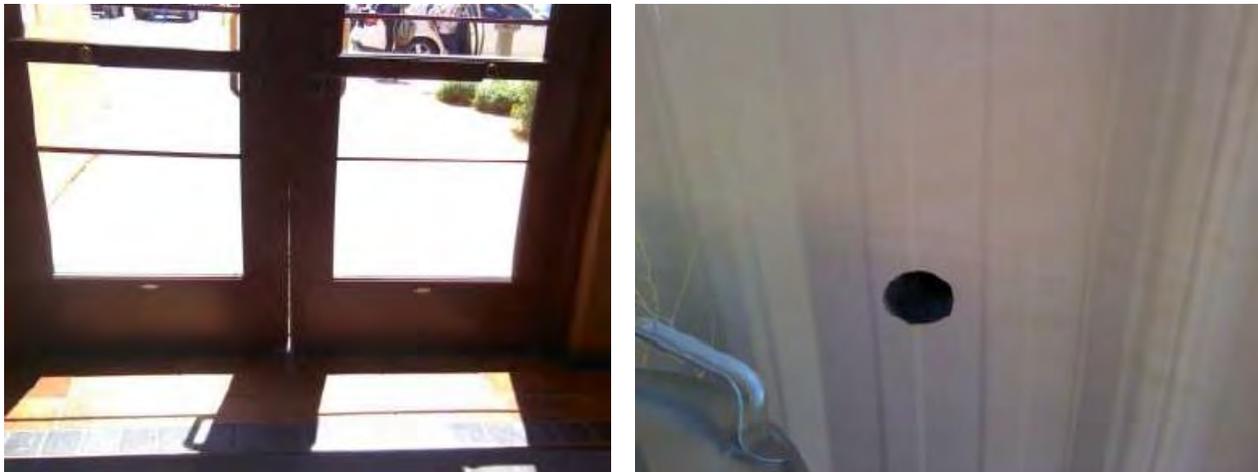
The roof is supported by steel joist and metal deck above the garage and built-up roof over metal deck above the living area. The exterior walls are most likely 6" metal studs at 16" on center, filled with batt insulation, a stucco exterior, and sheetrock interior. The windows and entrance doors with windows of this building are double paned with metal frame. There three large metal garage roll-up doors on both the north and south of the building where the fire trucks and ambulance are located. The largest area of infiltration/exfiltration is at the doors on all sides of the building. These doors would benefit from new weather-strip and door sweeps that would reduce energy consumption. Several penetrations and blank openings are located around the perimeter walls and sealing these would reduce air infiltration/exfiltration and energy loss.

Figure 40: Building Envelope Gaps at the Santa Fe Regional Airport

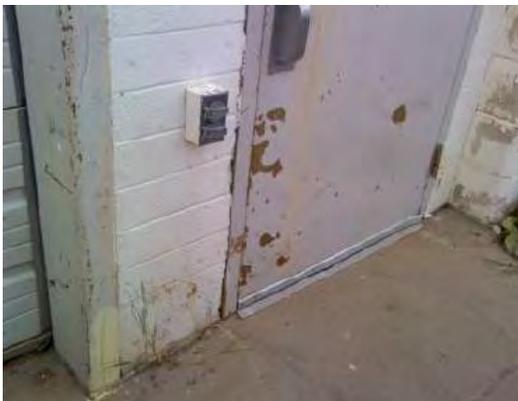
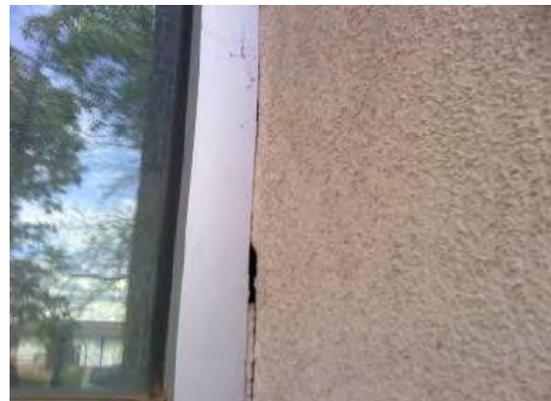
The exterior office walls have a tan stucco exterior while the taller garage walls are constructed from a light tan metal and furred out sheetrock interior with batt insulation. The majority of windows throughout the building are double paned. Entrance and additional auxiliary doors located around the building are single doors made of wood or metal. There are a number of large metal roll-up doors located at the garage bays. The largest area of infiltration/exfiltration is at the perimeter doors. These doors would benefit from new weather-strip and door sweeps that would reduce energy consumption. Several penetrations and blank openings are located around the perimeter walls and sealing these would reduce air infiltration/exfiltration and energy loss. Several windows on Building A have ineffective sealant and would also benefit from resealing.

Figure 44: Gaps in Building Envelope at Siler Complex Building C

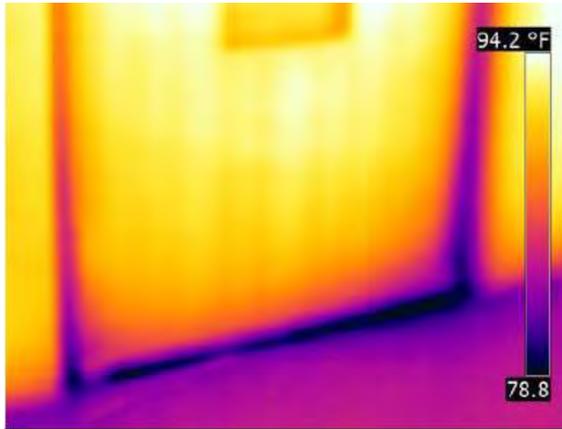
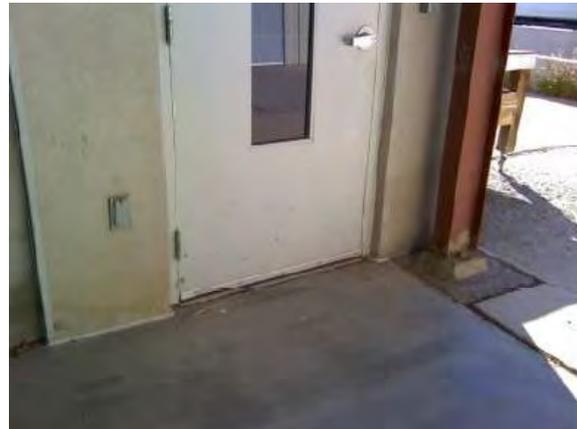
This building is a premanufactured metal building with a sloped metal roof and sheet metal exterior walls with rolled batt insulation. The largest amount of infiltration/exfiltration on these buildings was at the exterior doors. These doors would benefit from new door sweeps and weather stripping and some would require new sealant around the frame.

Figure 46: Thermal Imaging of Gaps in Building Envelope at Siringo Complex Warehouse

Sealing penetrations and blank openings is recommended to reduce air and moisture infiltration leading to reduce energy loss.

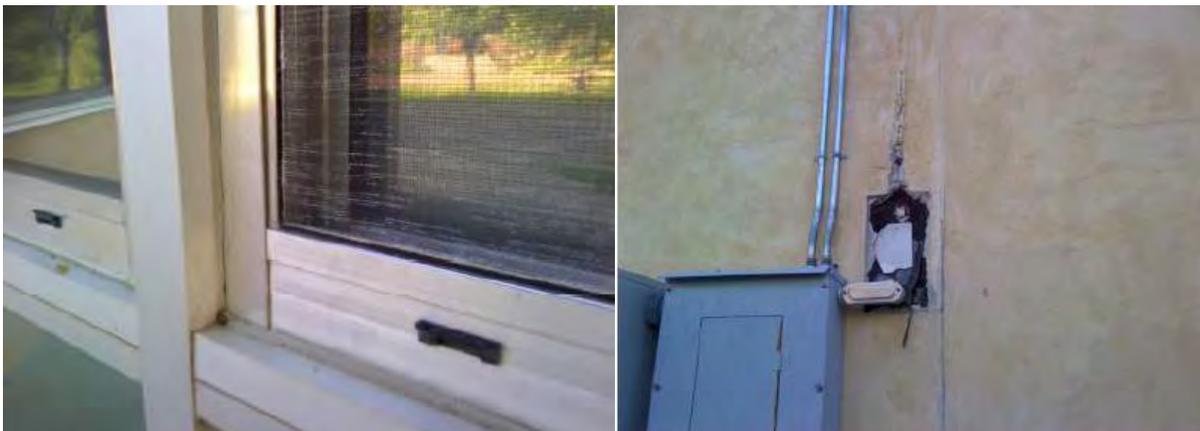
Figure 47: Additional Gaps in Building Envelope at Siringo Complex Warehouse

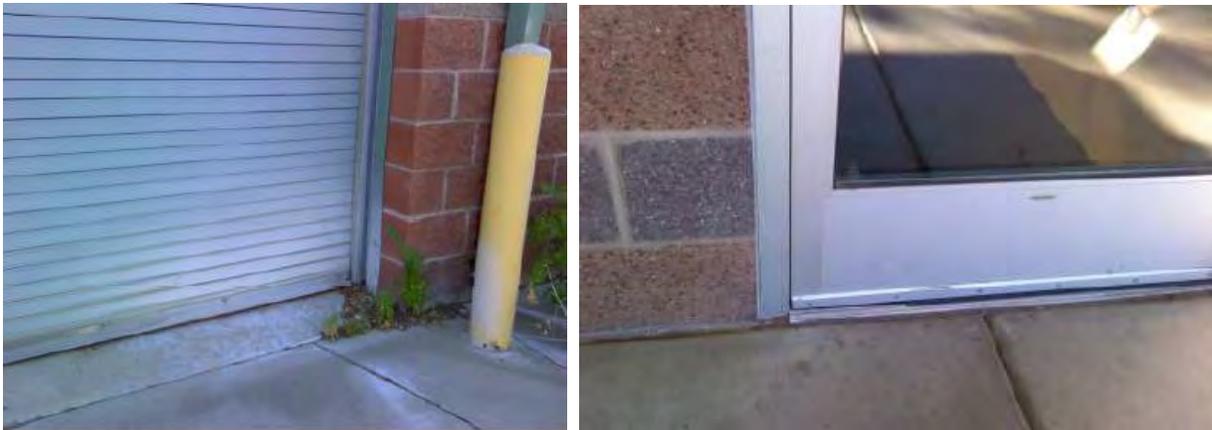
The largest area of infiltration/exfiltration is at the perimeter doors. These doors would benefit from new weather-strip and door sweeps that would reduce energy consumption. Several penetrations and blank openings are located around the perimeter walls and sealing these would reduce air infiltration/exfiltration and energy loss.

Figure 50: Gaps in Building Envelope at Transit Administration

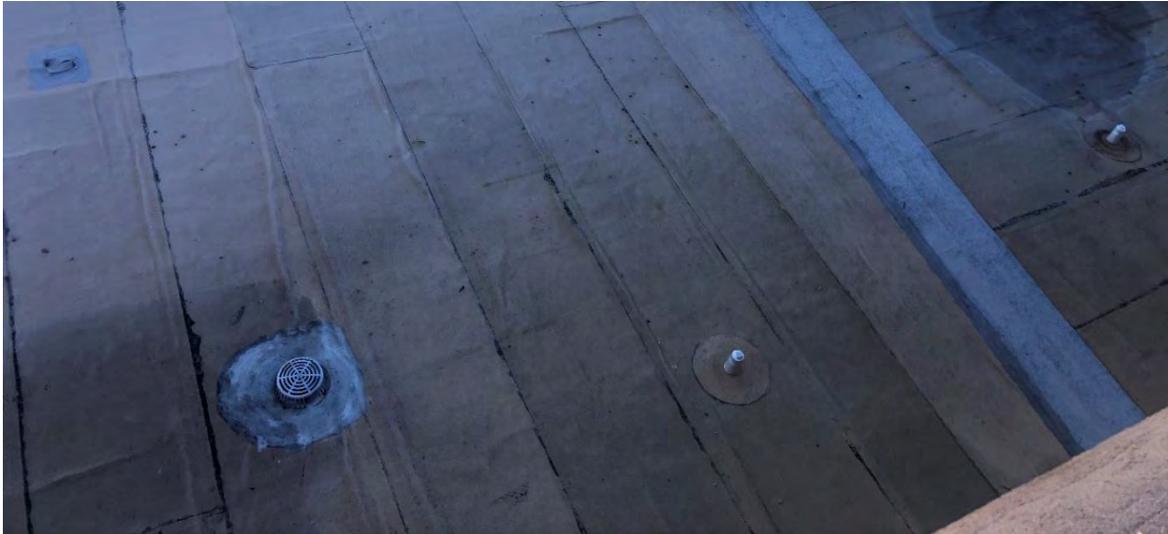
Figure 53: Roof Condition at Canyon Road Water Treatment Plant

- Replace the roof at the Canyon Road Water Treatment Plant in order reduce energy and operational costs and support the installation of rooftop solar PV.

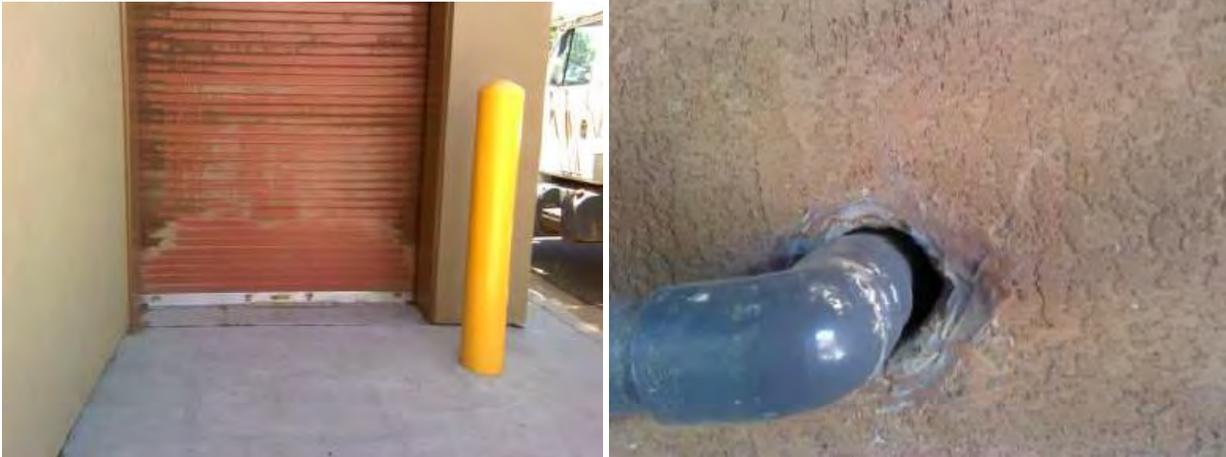
Figure 54: Gaps in Building Envelope at Canyon Road Water Treatment Plant

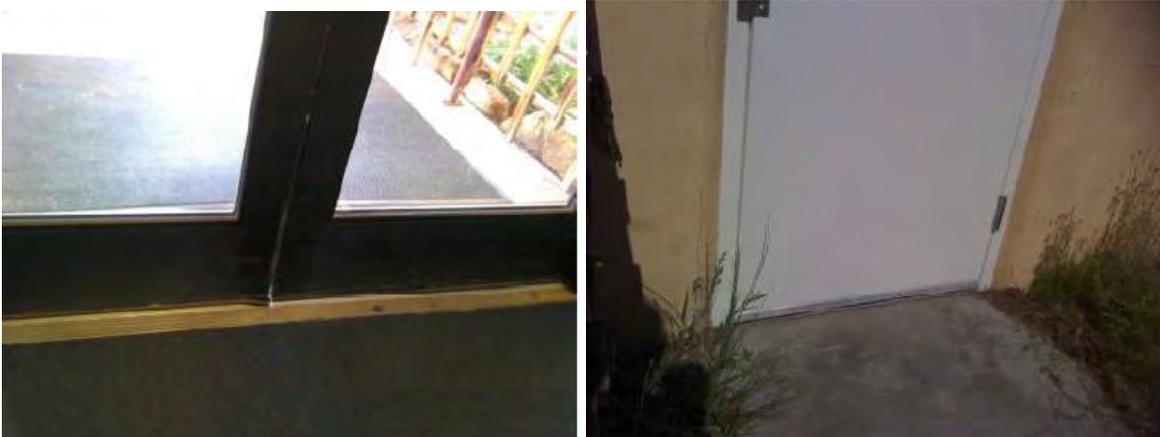
Figure 56: Gaps in Building Envelope at the Water Division Office
