IDENTIFICATION	ADDRESS: <u>630 Canyon Road</u>	ID NUMBER: <u>0516 11321</u>
	UTM REFERENCE EASTING NORTHING ZONE 12 13	LEGAL DESCRIPTION: TNSP <u>17</u> (N) S RANGE <u>10</u> (E) W SEC <u>30</u> NW <u>1/4</u> NW <u>1/4</u>
FIELD MAP <u>Santa Fe Historic Structures Survey, 1983-85/1992</u>		PHOTO
DATE OF CONSTRUCTION: by <u>1859</u> ESTIMATE _____ ACTUAL _____ SOURCE(S) <u>SR nomination</u>		
ARCHITECTURAL STYLE: <u>Spanish-Pueblo Revival</u>		BUILDING DATA
USE: HISTORIC: <u>residential</u> OTHER <u>artist studio</u>		
PRESENT: <u>residential</u> OTHER <u>artist studio & religious</u>		
SURROUNDINGS: <u>commercial/residential</u>		SITE PLAN
RELATIONSHIP TO HISTORIC SURROUNDINGS: <input checked="" type="checkbox"/> SIMILAR <input type="checkbox"/> NOT SIMILAR		
ASSOCIATED BUILDINGS ON SITE: <input checked="" type="checkbox"/> YES <input type="checkbox"/> NO		SIGNIFICANCE
WHAT TYPE? <u>cottage on south of property</u> IF INVENTORIED, LIST ID NUMBER(S) _____

NEW MEXICO HISTORIC BUILDING INVENTORY - SANTA FE RESURVEY 1993 (concluded)

BUILDING INSPECTION

structure Olive Rush Studio #303
 Date January 30, 1986
 By: Barbara Zook

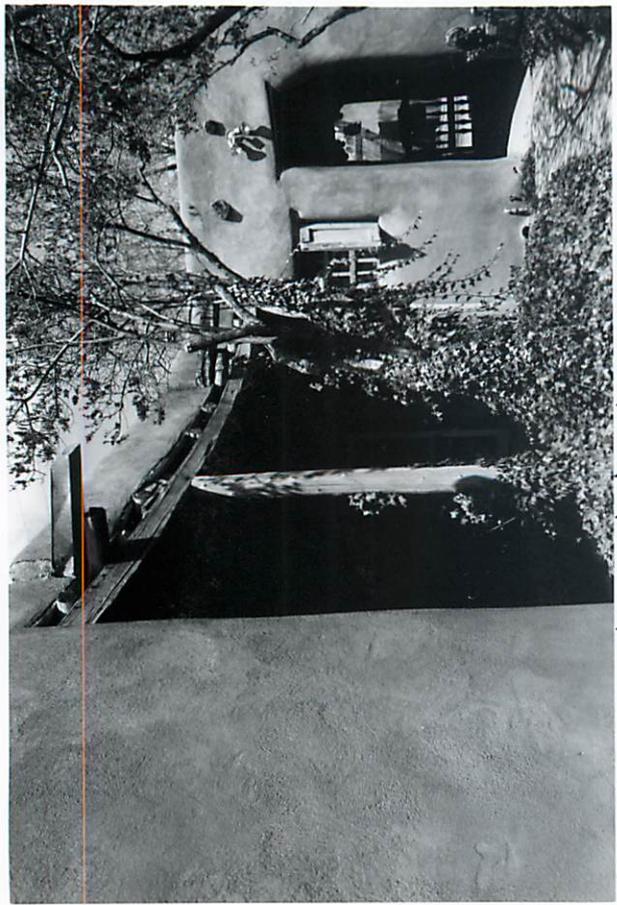
#27 east portal & passageway

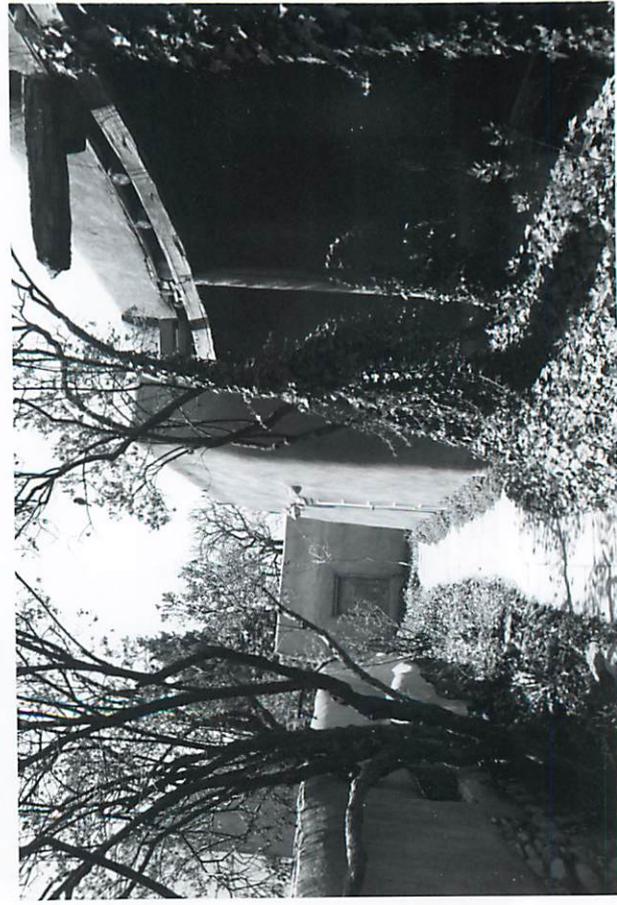
#26 east elevation (on right)

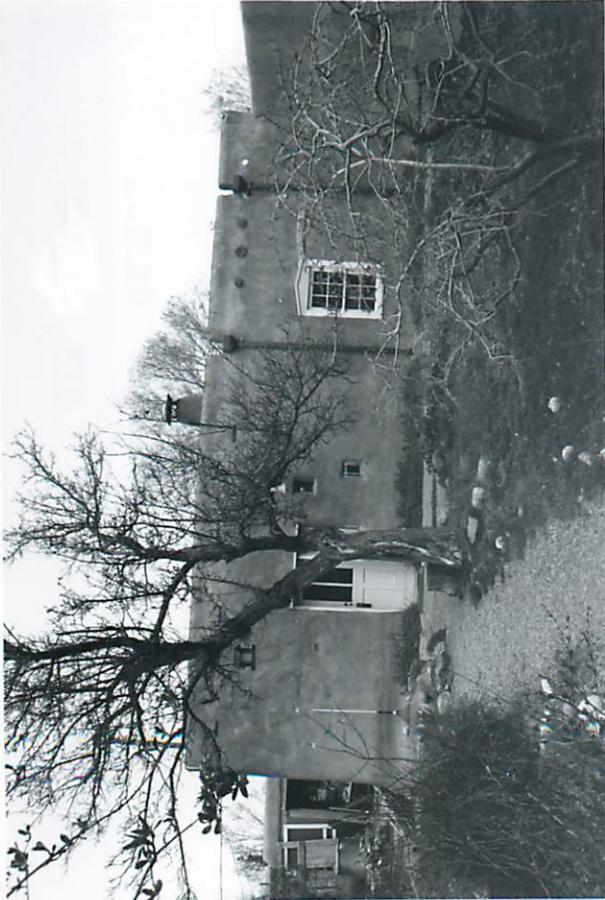
#28

south elevation

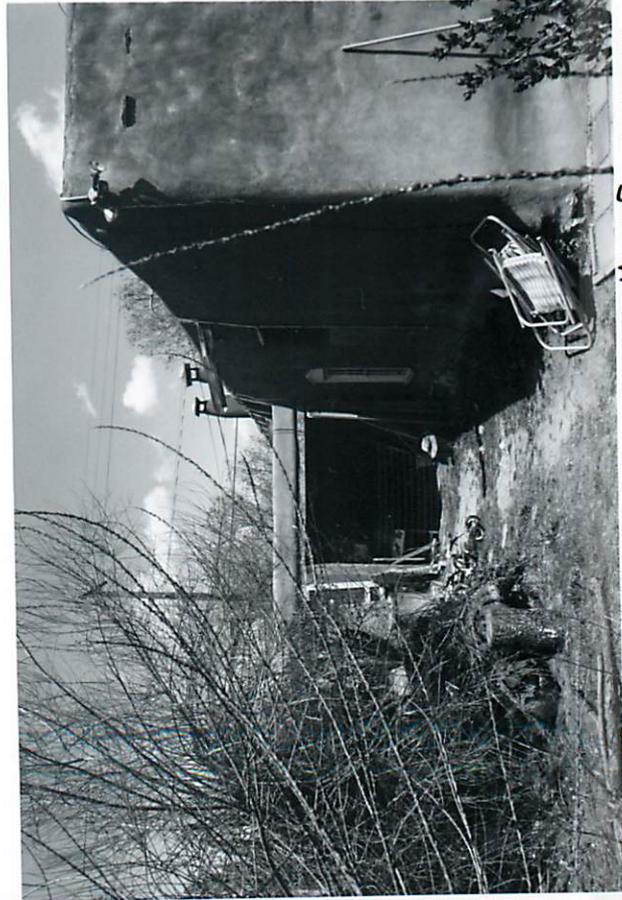
#30

west elevation of garage

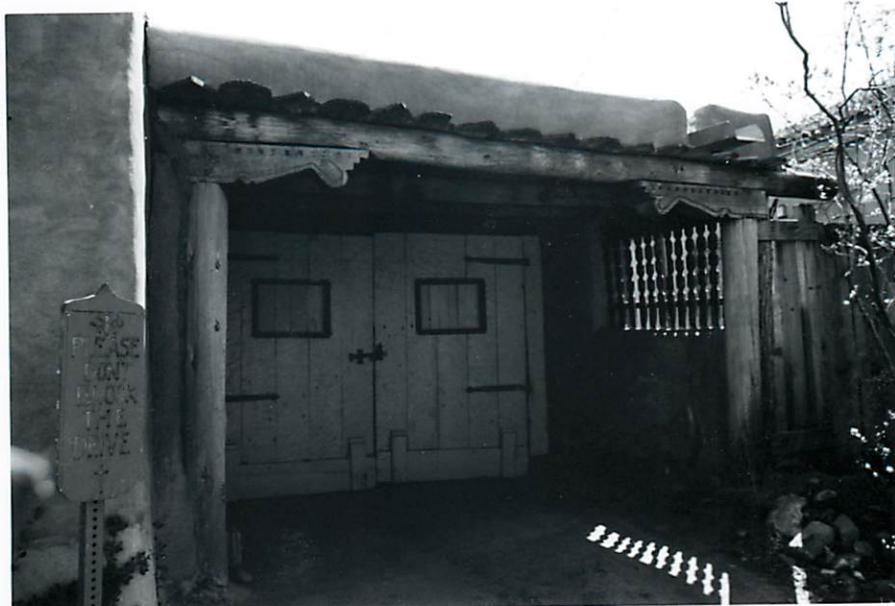
#18

garage north elevation

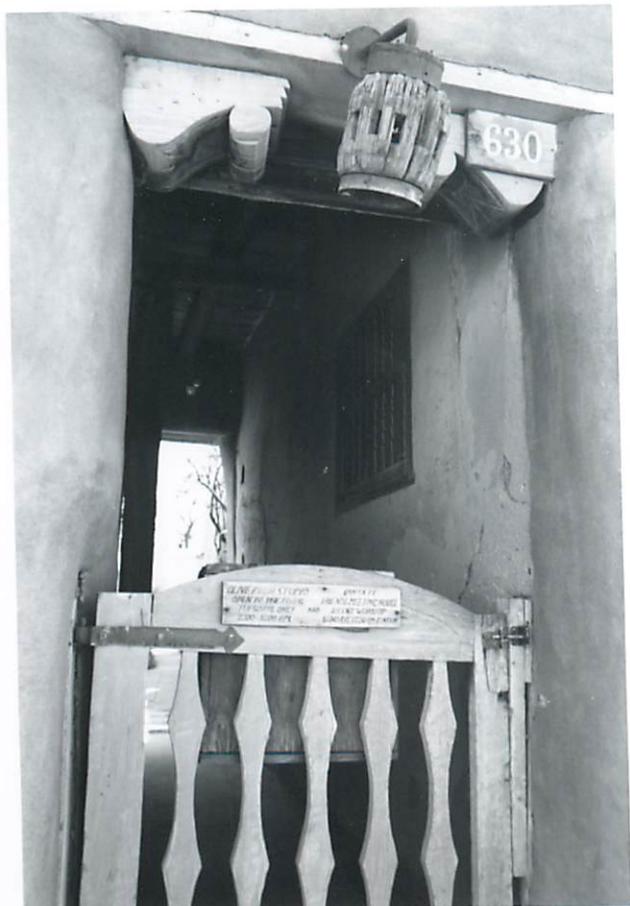
#17 east entry

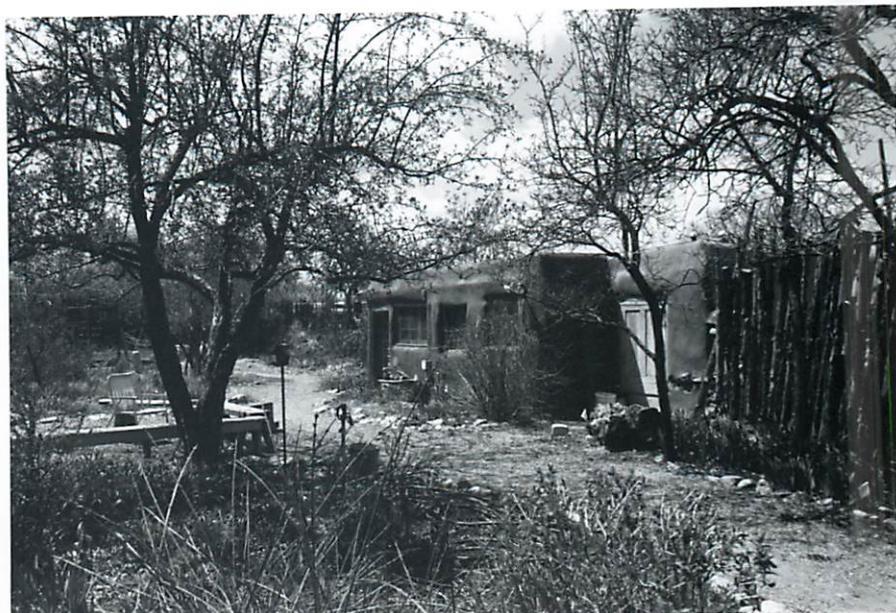
#29 cottage from NE

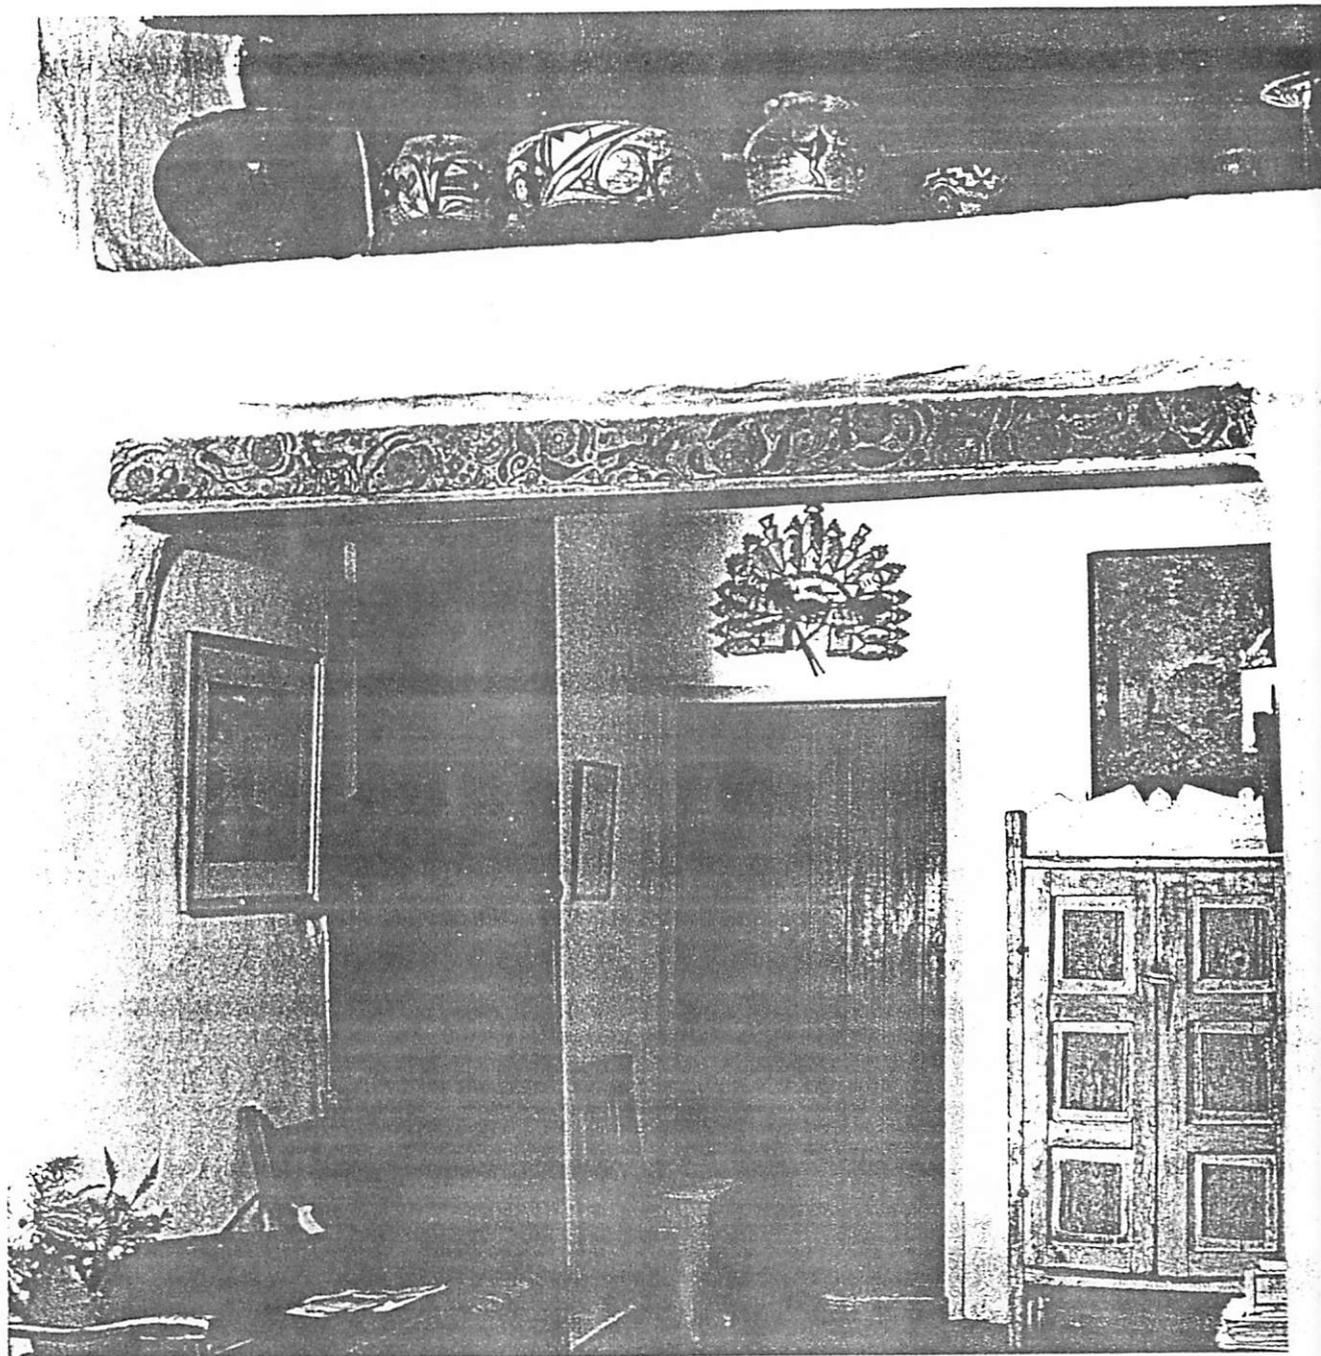
Interior of the RUSH STUDIO, with vigas painted by the artist and showing a collection of her art and furnishings.

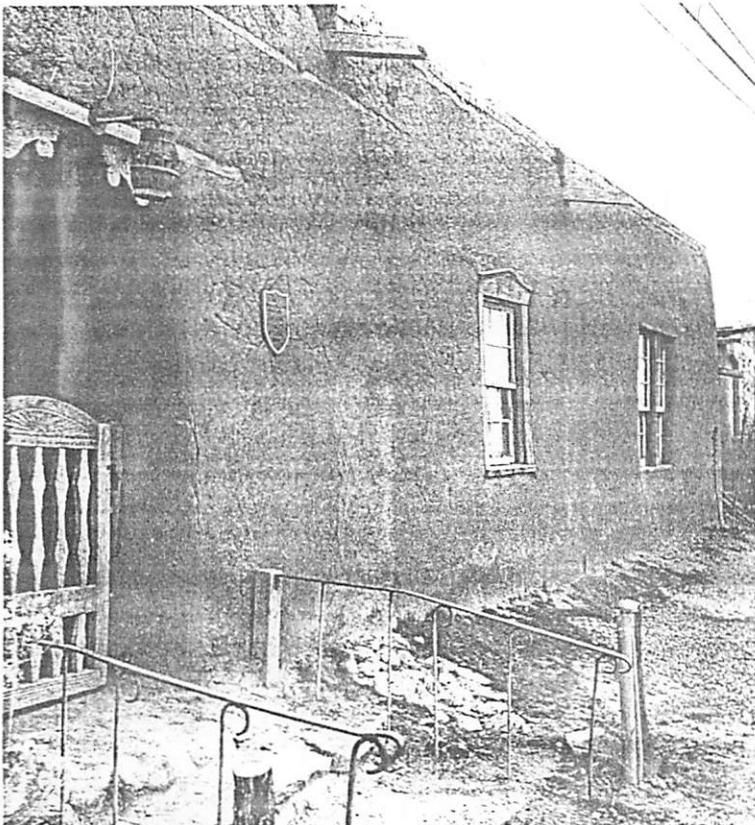
Exterior of the RUSH STUDIO, one of the few remaining mud-plastered buildings.
Karl Kernberger, photographer

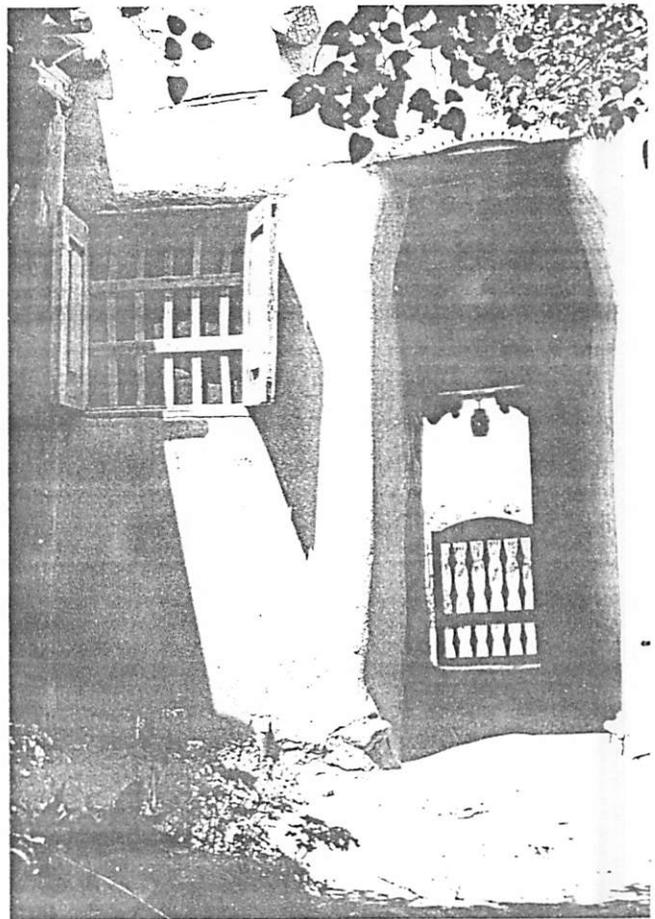
RUSH STUDIO entrance *placita*.
Karl Kernberger, photographer
