# City of Santa Fe

Investment Grade Audit (IGA) Report

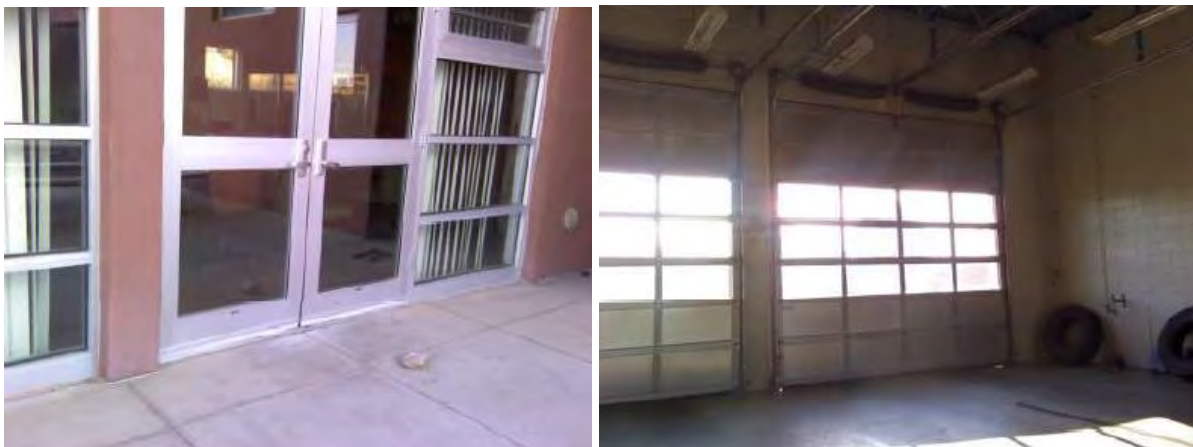
Figure 10: Gaps in building envelope at Fire Station #8

The exterior walls are most likely metal studs at 16" on center, filled with batt insulation covered by a brown stucco exterior and a sheetrock interior. Most windows throughout the building are double paned with a metal frame. There are several 2'x2' and 4'x4' skylights above the living areas that penetrate the sloped metal roof. Located above the fire truck garage are nine 2'x6' skylights. The main public entrance is at the north side of the building through a metal-framed door with large window sections. An additional door is located on the east side and accessed from the parking lot. Auxiliary entrances located around the building are single doors made of wood or metal. The largest area of infiltration/exfiltration is at the doors on all sides of the building. These doors would benefit from new weather-strip and door sweeps that would reduce energy consumption.

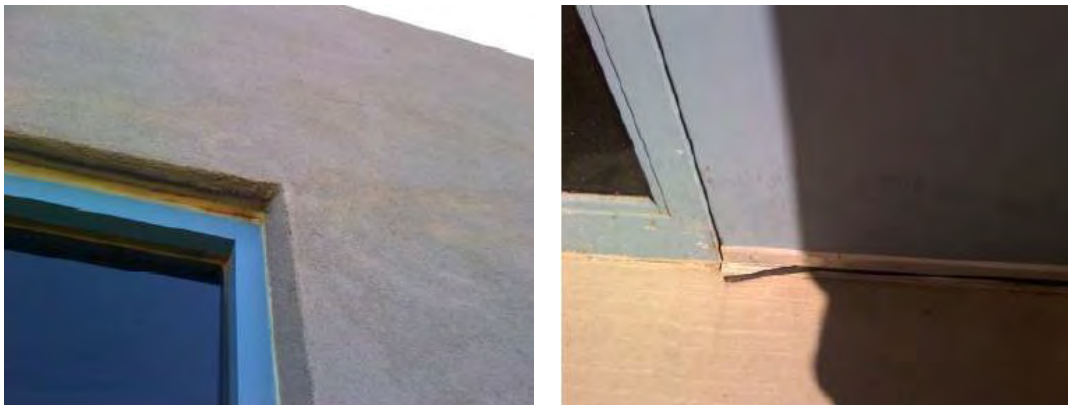
Figure 20: Flaws in building envelope at La Familia Medical Center

The roof is supported by metal deck over steel joists and trusses with batt insulation in the ceiling space and a white TPO cover. The exterior walls are constructed with metal studs on 16" spacing with batt insulation in between a tan stucco exterior and built out sheetrock interior. The majority of windows throughout the building are double paned with aluminum frame. There is a window wall storefront entrance of the main parking lot with double doors. The main entrance on the east side of the building is through a set of metal double-doors. Auxiliary entrances located around the building are single doors made of wood or metal. The largest area of infiltration/exfiltration is at the doors on all sides of the building. These doors would benefit from new weather-strip and door sweeps that would reduce energy consumption. Several penetrations and openings are located around the perimeter walls and sealing these would reduce air infiltration/exfiltration and energy loss. Some windows would benefit from a resealing.

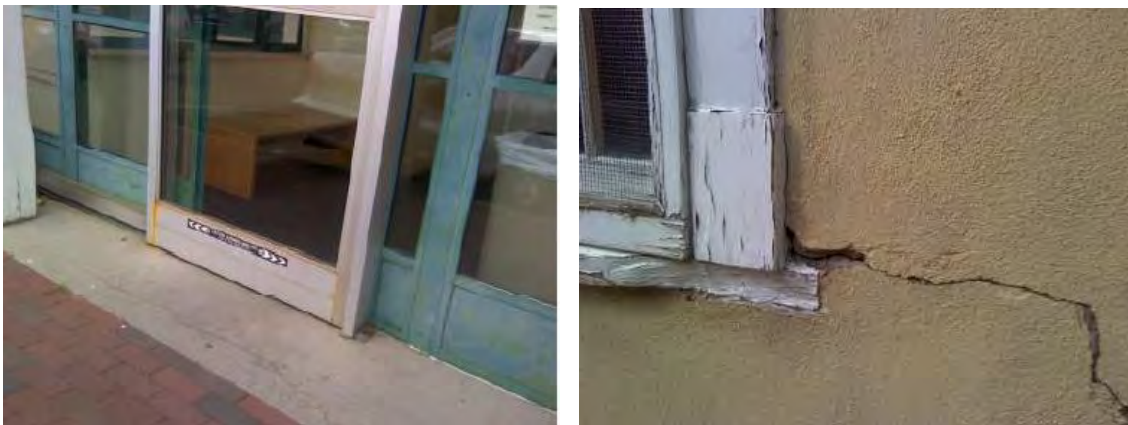
Figure 26: Building envelope issues at the Main Library

The flat roof is supported by wood trusses or metal joist and batt insulation in the ceiling space and built-up roof with a modified bitumen exterior. The exterior walls are constructed with studs at 16" on center, filled with batt insulation, a stucco exterior, and sheetrock interior. Additional walls are made of adobe. The basement wall is constructed from cast-in-place concrete. The majority of windows throughout the building are single paned with metal frame. The main entrances located on the east and west side of the building are through a set of metal doors with large window sections. The largest area of infiltration/exfiltration is at the doors on all sides of the building. These doors would benefit from new weather-strip and door sweeps that would reduce energy consumption. Several penetrations and blank openings are located around the perimeter walls and sealing these would reduce air infiltration/exfiltration and energy loss. We also recommend sealing approximately 40 feet of wall cracks.

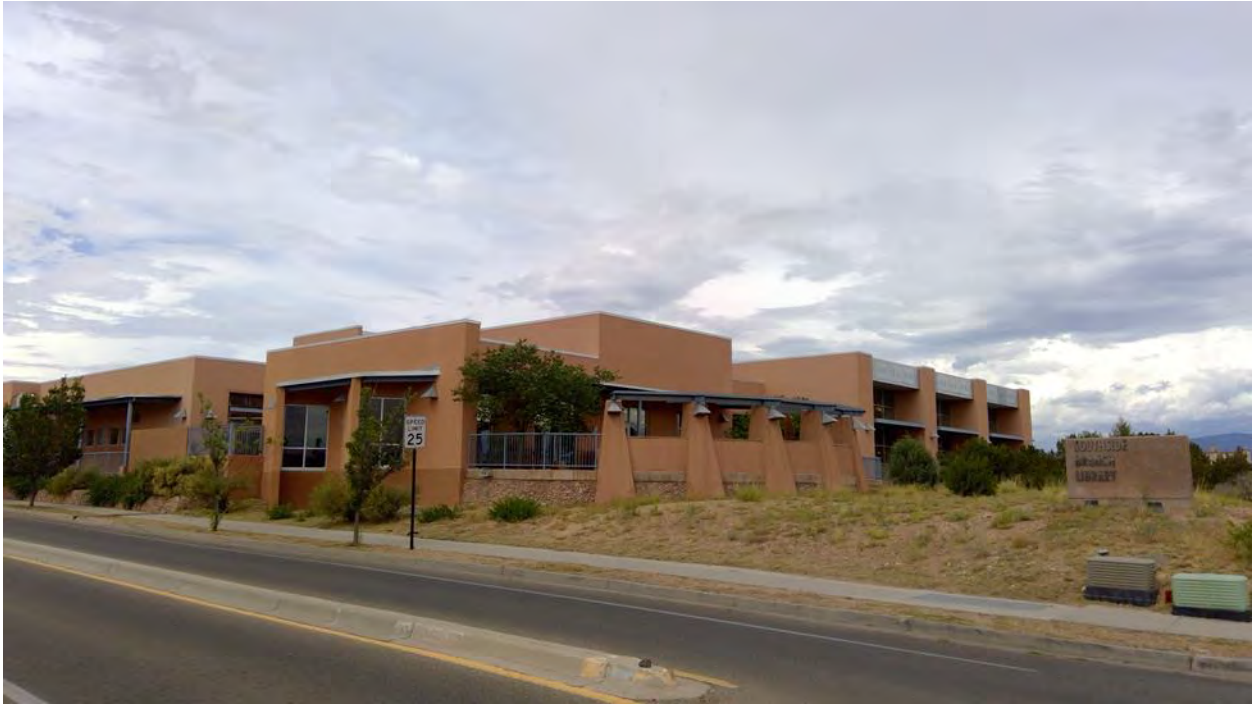
Figure 28: Southside Library Exterior

There are two types of a roof on this building. Firstly, a flat built-up roof that covers the majority of the roof with a 60-mil adhered EPDM roof system supported by metal deck and steel joist. There are multiple punctures in the membrane and deteriorating patches with unknown material. It is apparent with the amount of patchwork present that the library has experienced leaks. These repairs have most likely voided the original manufacturer warranty. The second is a sloped corrugated metal roof, located above the entrance and portions of the elevated roof in the center of the building.

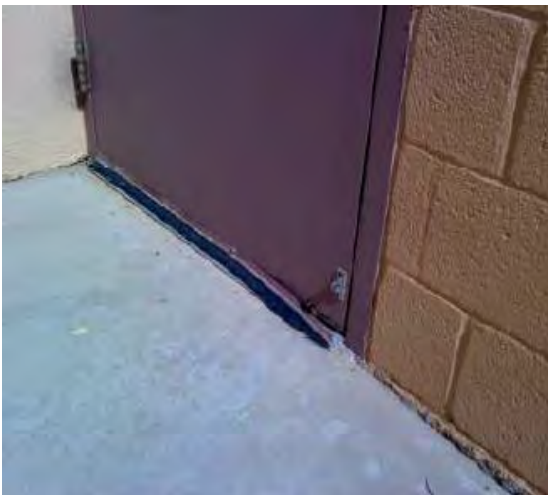
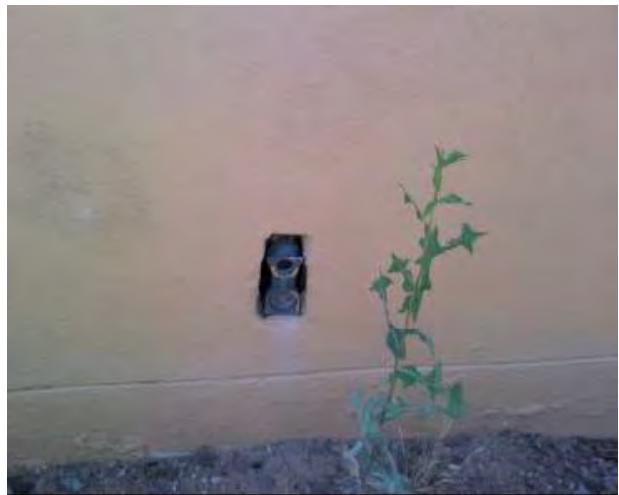
Both the upper roof above the natatorium and lower roof above the lobby and offices are constructed with metal roof deck supported by steel joist and batt insulation in the ceiling space with a built-up roof with exterior TPO. The exterior walls are concrete masonry unit (CMU) blocks with split face or brown stucco and interior furred out sheetrock walls. The majority of windows throughout the building are double paned with an aluminum frame on the exterior and interior. There is a glass block section below the windows around the lobby. The main entrance on the west side of the building is through a set of double doors with windows. The southside entrance to the pool is via similar double doors with windows and auxiliary entrances located around the building are single doors made of wood or metal. The largest area of infiltration/exfiltration is at the doors on all sides of the building. These doors would benefit from new weather-strip and door sweeps that would reduce energy consumption. Several penetrations and blank openings are located around the perimeter walls and sealing these would reduce air infiltration/exfiltration and energy loss.

Figure 32: Building envelope issues at Salvador Perez Swimming Pool

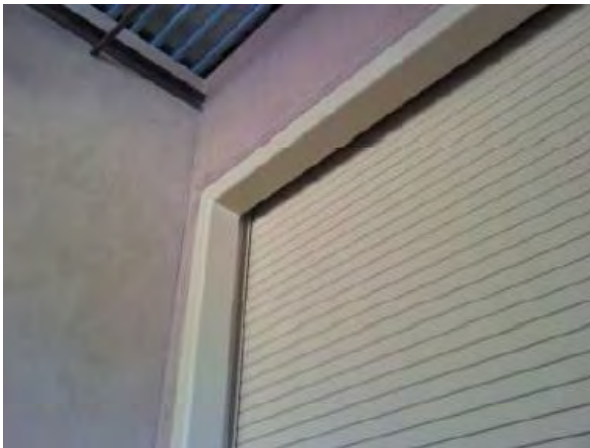
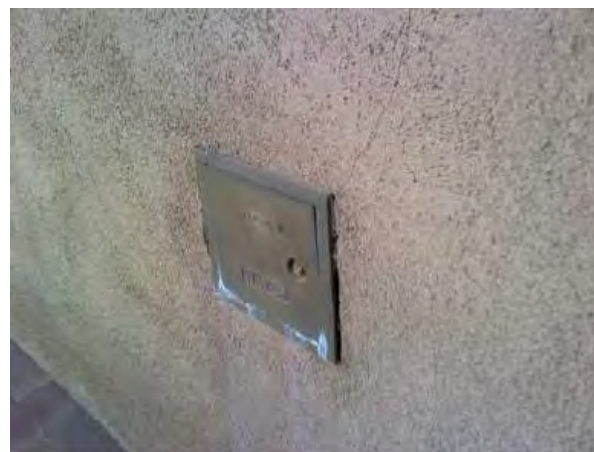
The roofs are flat and structurally supported by metal deck over steel joist with batt insulation in the ceiling space and built-up roof with TPO exterior. The exterior walls are most likely 6" steel studs at 16" on center, filled with batt insulation, a dark tan stucco exterior, and sheetrock or gypsum board interior. The majority of windows throughout the building are double paned with various color frames. Located around the building are several large public entrances through multiple doors with large window sections. Auxiliary entrances located around the building have single doors made of wood or metal. Located on the loading dock in the back of the building are large Metal roll-up doors. The largest area of infiltration/exfiltration is at the doors on all sides of the building. These doors would benefit from new weather-strip and door sweeps that would reduce energy consumption. Several penetrations and blank openings are located around the perimeter walls and sealing these would reduce air infiltration/exfiltration and energy loss.

Figure 35: Building Envelope Gaps at SFCC

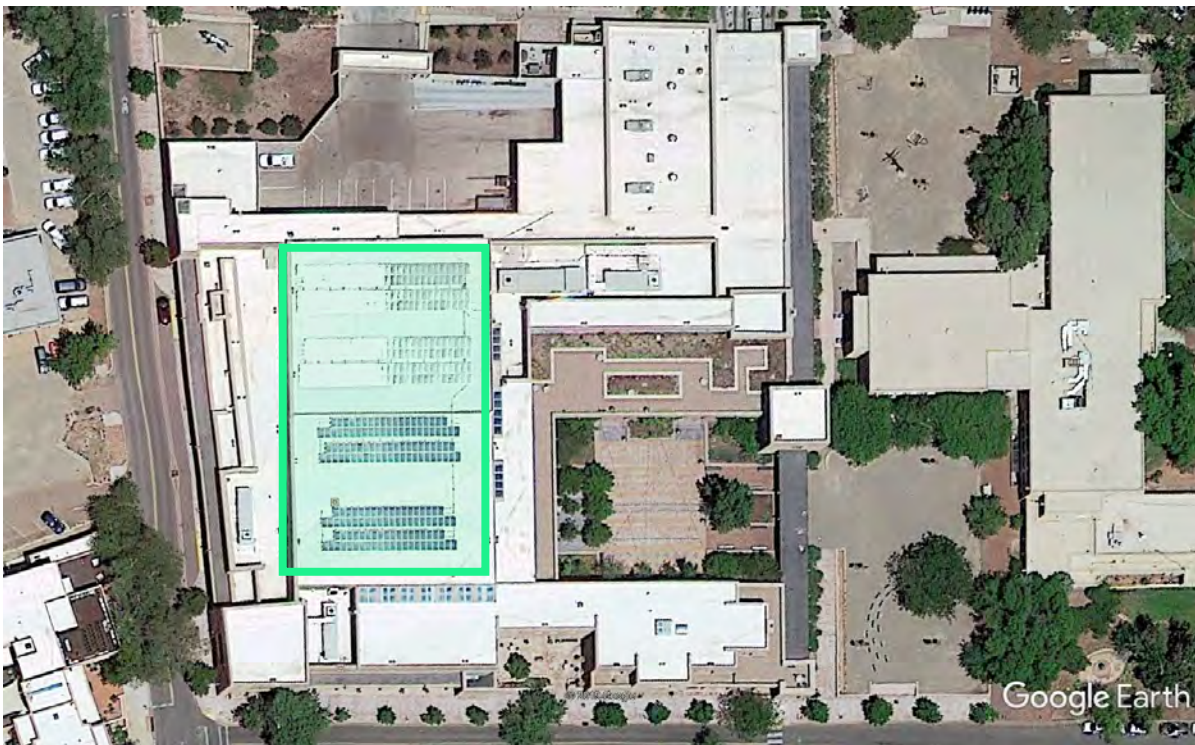
The city entered a power purchase agreement (PPA) with Dissigno Holdings that installed a roof-mounted solar PV system. According to staff, there are occasional inverters that fail and go off the line that reduces the system production. Additional information regarding rate and production is available in the Baseline Utility Analysis section of this report.

Figure 36: Solar PV System installed at SFCC

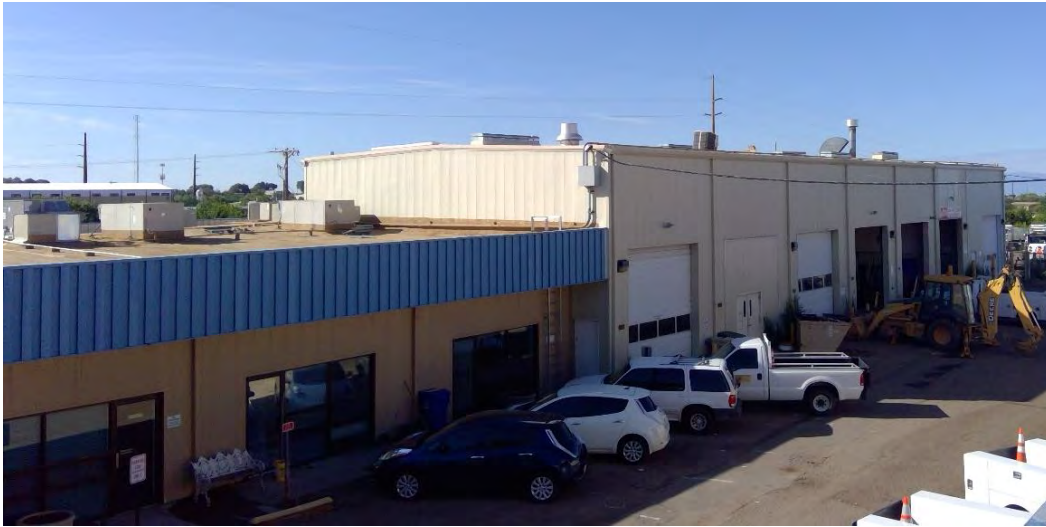
Figure 43: Siler Complex Building C Building Exterior

The exterior office walls have a tan stucco exterior while the taller garage walls are constructed from a light tan metal and furred out sheetrock interior with batt insulation. The majority of windows throughout the building are double paned. Entrance and additional auxiliary doors located around the building are single doors made of wood or metal. There are a number of large metal roll-up doors located at the garage bays. The largest area of infiltration/exfiltration is at the perimeter doors. These doors would benefit from new weather-strip and door sweeps that would reduce energy consumption. Several penetrations and blank openings are located around the perimeter walls and sealing these would reduce air infiltration/exfiltration and energy loss. Several windows on Building A have ineffective sealant and would also benefit from resealing.

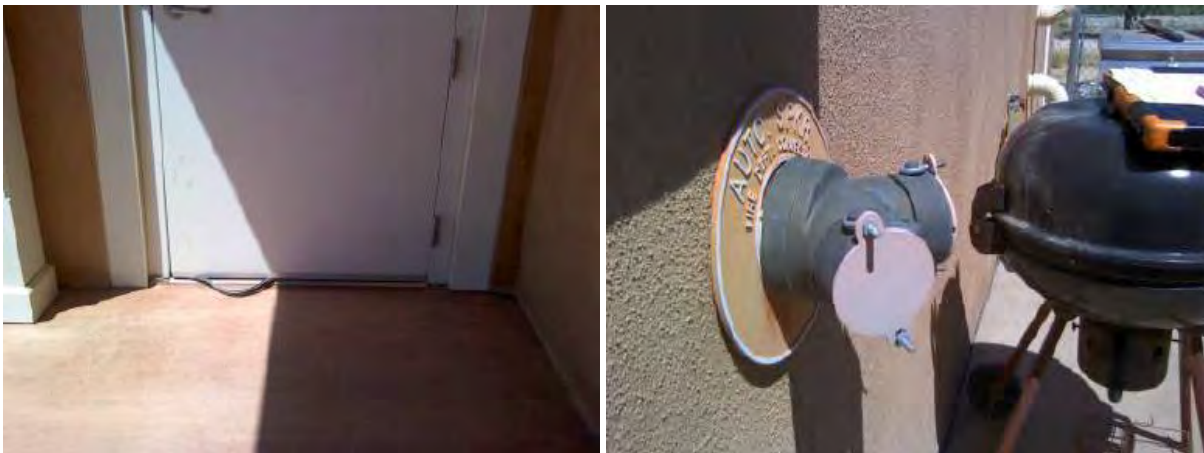
Figure 65: Gaps in Building Envelope at BDD Main

The roof was not accessed at the time of visit but is flat with what appears to be a TPO exterior supported by steel joists with metal decking and batt insulation in the ceiling space. The exterior walls are 2"x6" metal at 16" on center, filled with batt insulation, covered with a tan stucco exterior, and sheet rocked interior. The majority of windows throughout the building are double paned, including a large window wall at the entrance. The main entrance on the east side of the building is through a set of metal double-doors with windows. An additional metal door with windows is located on the west side. Auxiliary entrances located around the building are single doors made of wood or metal. The largest area of infiltration/exfiltration is at the doors on the building perimeter. These doors would benefit from new weather-strip and door sweeps that would reduce energy consumption. Sealing several penetrations around the perimeter walls would reduce air infiltration/exfiltration and energy loss.

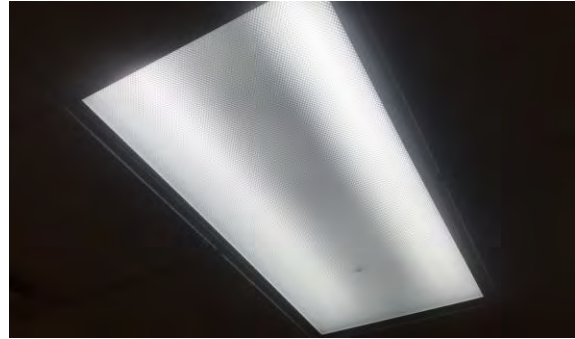
T8 fluorescent troffers, shown here with a prismatic lens, are by far the most common light fixture in the COSF. They are found in most office space areas. On average, each of these fixtures consumes 87 watts of power.

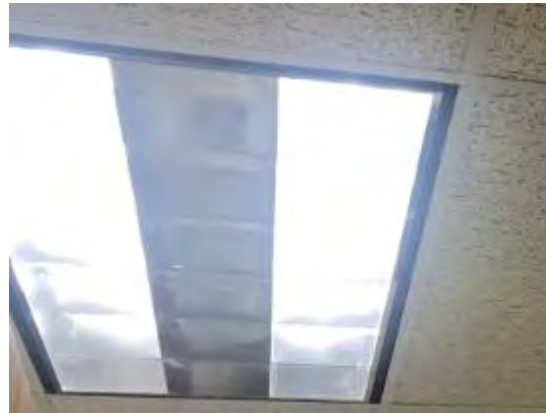
While not as widespread as T8s, T12 fluorescent troffers are common within COSF. On average, each of these fixtures consumes 107 watts of power.

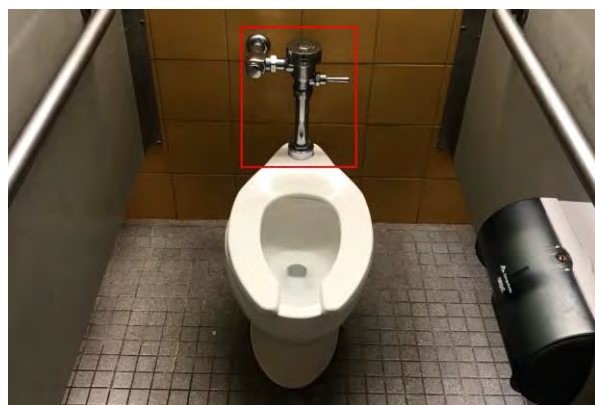
Flushometers like those shown at right are prone to leakage and in many cases have fallen into disrepair, resulting in a release of much more water than is necessary. This measure will rebuild and re-tune flushometer assemblies to combat water waste.

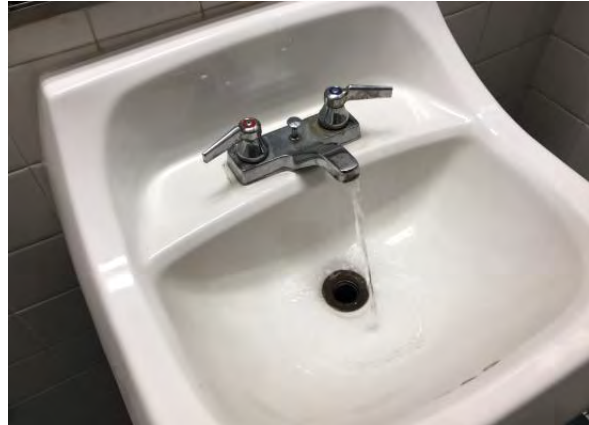
This faucet is an example of a fixture whose aerator has either been removed or was never present. Installation of flow control devices will reduce water consumption at these fixtures.

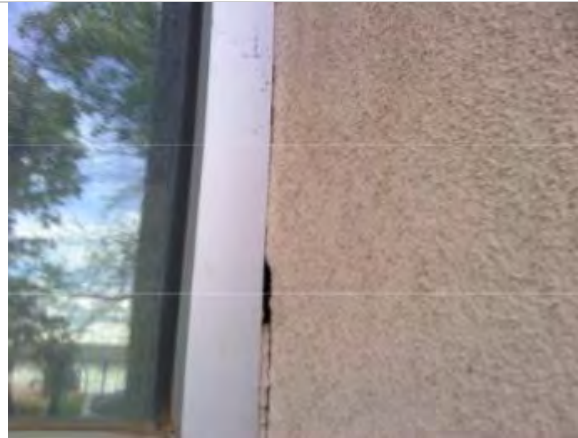
Gaps at window / wall junction should be sealed as shown at the Siler Complex.

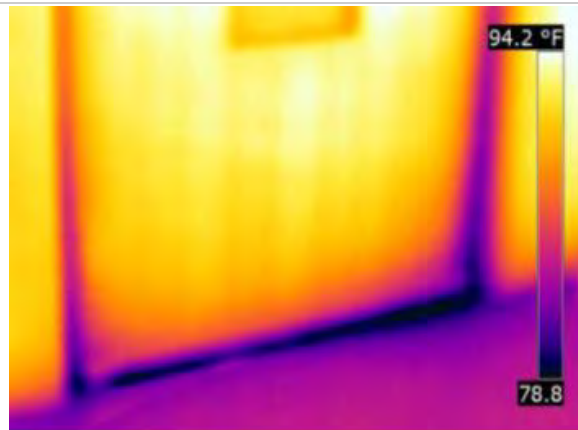
The thermal image at right shows a typical example of failed weather-stripping at exterior doors. Here dark blue at the edges of the doors signify a large temperature differential is apparent, signaling severe leakage.

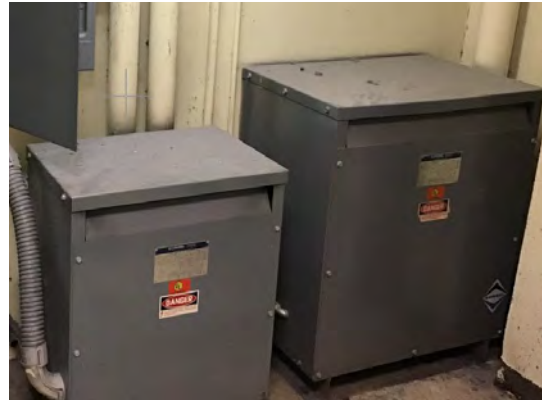
Several transformers like those shown at right are present throughout the electrical rooms in the facilities. Most of these units have been in place since the time of the facility's original construction.

Modifications will include replacement of the existing transformers, shown in Table 109 and Table 110, with new, high-efficiency Powersmiths' model E-Saver-80R transformers. Energy savings are driven by modern, precision-crafted cores and coil windings. Refer to **Appendix H3** for specifications.

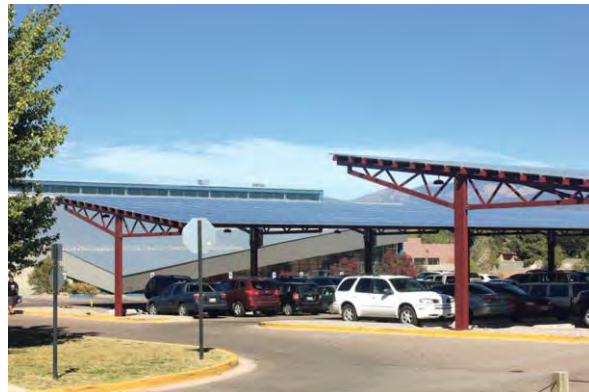
#### GCCC Solar Carport

A report provided by the original installer, is available in **Appendix J**. YE reviewed this report and system independently. The main causes of the reduction in PV system production are the electric panel breakers tripping and inverter failures. Recently, the system production has been limited so not to trip the breakers. This has increased the production from the prior breaker tripping, but the system is far below full production capacity, and this is not a desirable long-term solution. The solar production is recorded by REC meters; one for each of the two systems that serve the facility. The reduced solar production caused an increase in grid provided consumption. PNM, the utility company, in early 2019 PNM changed the rate for account 115447884-1174415-5 from 2A to 3B, a less advantageous rate for solar production. Design drawings are from 2013 and the system was installed shortly after. Typical inverter warranty is for ten years which means the warranty is ending soon and this is important since there have been inverter failures recently.

This system provides shade for the parked cars along with a roof mounted solar PV system.

The proposed modifications would repair the system to its original design production and include replacing the existing breaker panels, invertors, and install a remote monitoring system that would allow to validate production.

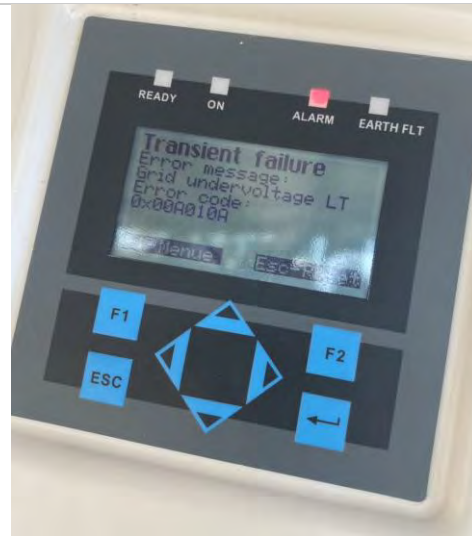
## Inverter Errors

Besides inverter failures, multiple inverters are showing error messages that are limiting the system potential production.

1. Replace all 26 existing inverters with 26 Chint Power Systems 23kW AC inverters with Standard 10-Year Warranty.
2. Replace existing 600V wiring with 1000V rated wiring.
3. Install appropriately sized back feed breakers where applicable.
4. Install remote monitoring systems for both PV systems.
5. Existing solar PV modules and carport racking equipment to remain.
6. Perform system commissioning and system optimization tests to ensure the solar system will produce energy as intended as follows:

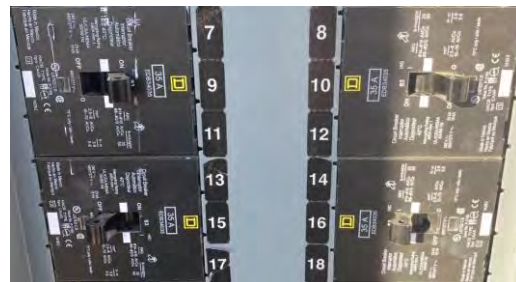
## Tripped Breakers

Multiple breakers are tripped, and these have been reset and not able to stay on during higher system production times, reducing the overall system production.

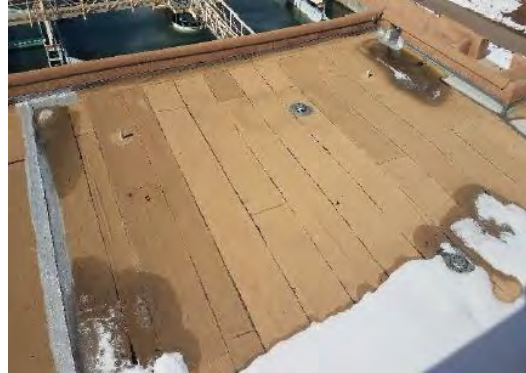
#### South Low Roof

The photo at right shows evidence of severe weathering on the roof material.

Replacement of the entire Canyon Road WTP Main Building roof surface is recommended due to age-related deterioration noted above. No HVAC equipment or systems are included in the work scope. Should the COSF decide to replace the HFAC equipment at this facility in the future, YE recommends that the engineer of record perform the load calculations to properly size the equipment based on conditions at that time.

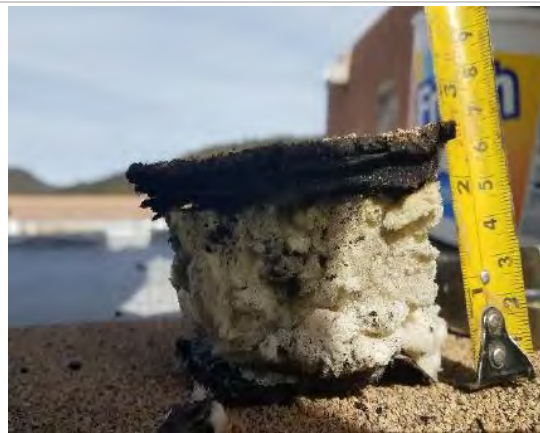
#### Low Roof Core Drill

Roof core, low roof section, showing 2" Polyiso, 3ply BUR, Cap sheet, hot asphalt.
