City of Santa Fe

Investment Grade Audit (IGA) Report

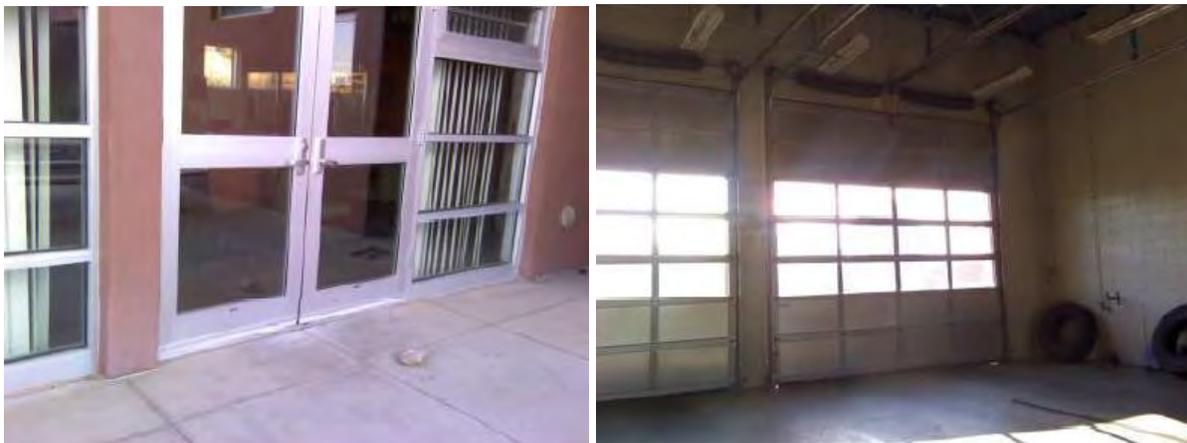
Figure 10: Gaps in building envelope at Fire Station #8

The exterior walls are most likely metal studs at 16" on center, filled with batt insulation covered by a brown stucco exterior and a sheetrock interior. Most windows throughout the building are double paned with a metal frame. There are several 2'x2' and 4'x4' skylights above the living areas that penetrate the sloped metal roof. Located above the fire truck garage are nine 2'x6' skylights. The main public entrance is at the north side of the building through a metal-framed door with large window sections. An additional door is located on the east side and accessed from the parking lot. Auxiliary entrances located around the building are single doors made of wood or metal. The largest area of infiltration/exfiltration is at the doors on all sides of the building. These doors would benefit from new weather-strip and door sweeps that would reduce energy consumption.

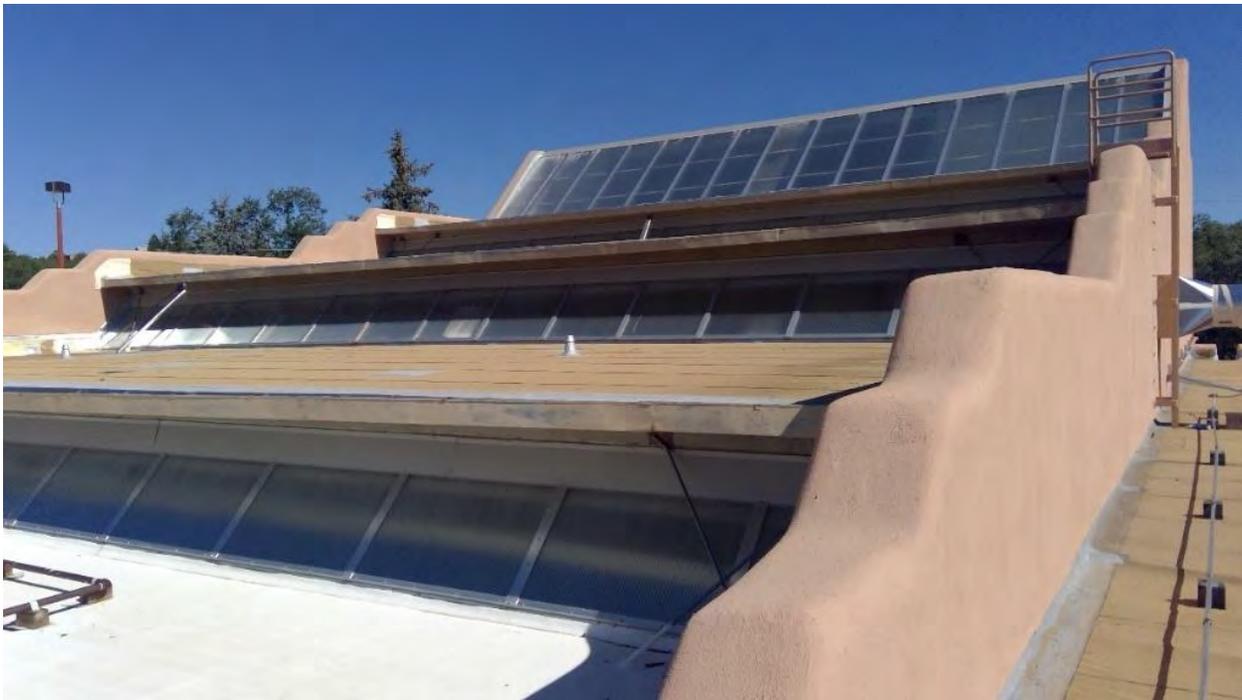
Figure 12: Existing Roof above Fort Marcy Recreation Center Swimming Pool

The roof is supported by a metal deck over steel joists and trusses. It has batt insulation in the ceiling space and a modified bituminous cover. The exterior walls are concrete masonry unit (CMU) blocks with a tan stucco exterior and built out sheetrock interior. Most windows throughout the building are double paned with aluminum frame. The office area underwent a renovation a few years ago. Above the swimming pool area where the roof steps there are sloped window walls. Additionally, located over the gymnasium are twelve skylights.

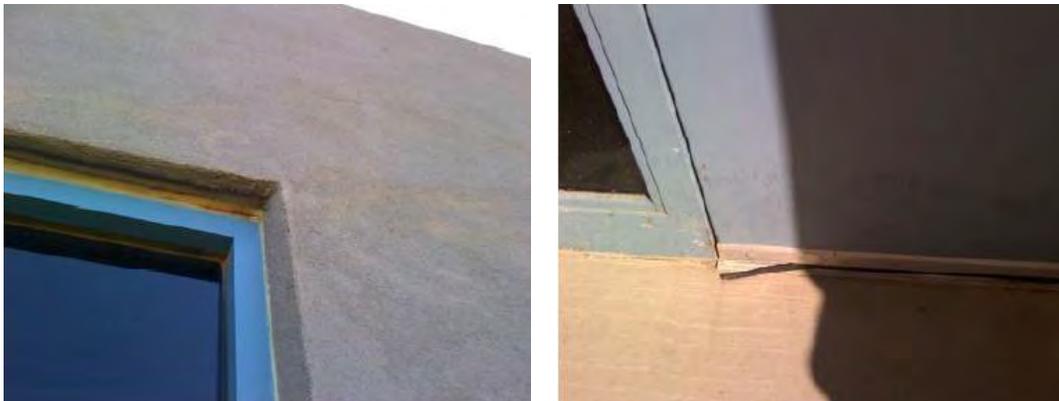
Figure 20: Flaws in building envelope at La Familia Medical Center

The roof is supported by metal deck over steel joists and trusses with batt insulation in the ceiling space and a white TPO cover. The exterior walls are constructed with metal studs on 16" spacing with batt insulation in between a tan stucco exterior and built out sheetrock interior. The majority of windows throughout the building are double paned with aluminum frame. There is a window wall storefront entrance of the main parking lot with double doors. The main entrance on the east side of the building is through a set of metal double-doors. Auxiliary entrances located around the building are single doors made of wood or metal. The largest area of infiltration/exfiltration is at the doors on all sides of the building. These doors would benefit from new weather-strip and door sweeps that would reduce energy consumption. Several penetrations and openings are located around the perimeter walls and sealing these would reduce air infiltration/exfiltration and energy loss. Some windows would benefit from a resealing.

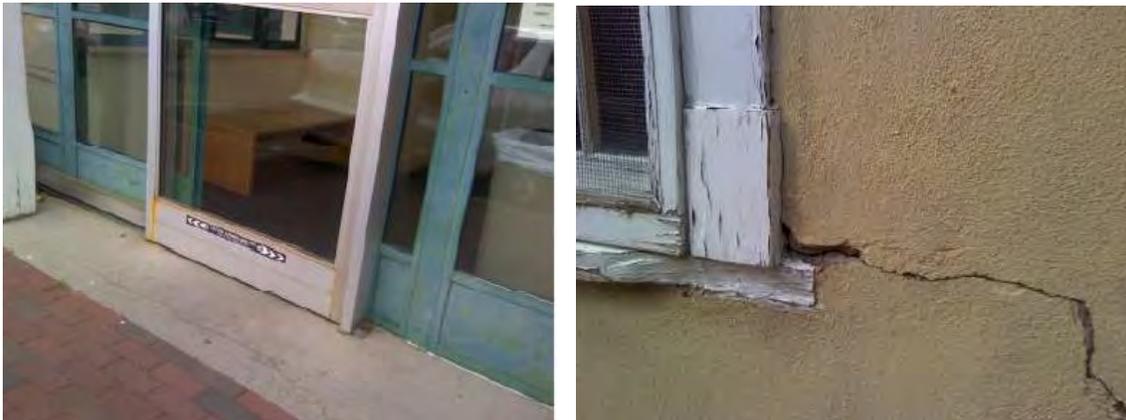
Figure 26: Building envelope issues at the Main Library

The flat roof is supported by wood trusses or metal joist and batt insulation in the ceiling space and built-up roof with a modified bitumen exterior. The exterior walls are constructed with studs at 16" on center, filled with batt insulation, a stucco exterior, and sheetrock interior. Additional walls are made of adobe. The basement wall is constructed from cast-in-place concrete. The majority of windows throughout the building are single paned with metal frame. The main entrances located on the east and west side of the building are through a set of metal doors with large window sections. The largest area of infiltration/exfiltration is at the doors on all sides of the building. These doors would benefit from new weather-strip and door sweeps that would reduce energy consumption. Several penetrations and blank openings are located around the perimeter walls and sealing these would reduce air infiltration/exfiltration and energy loss. We also recommend sealing approximately 40 feet of wall cracks.

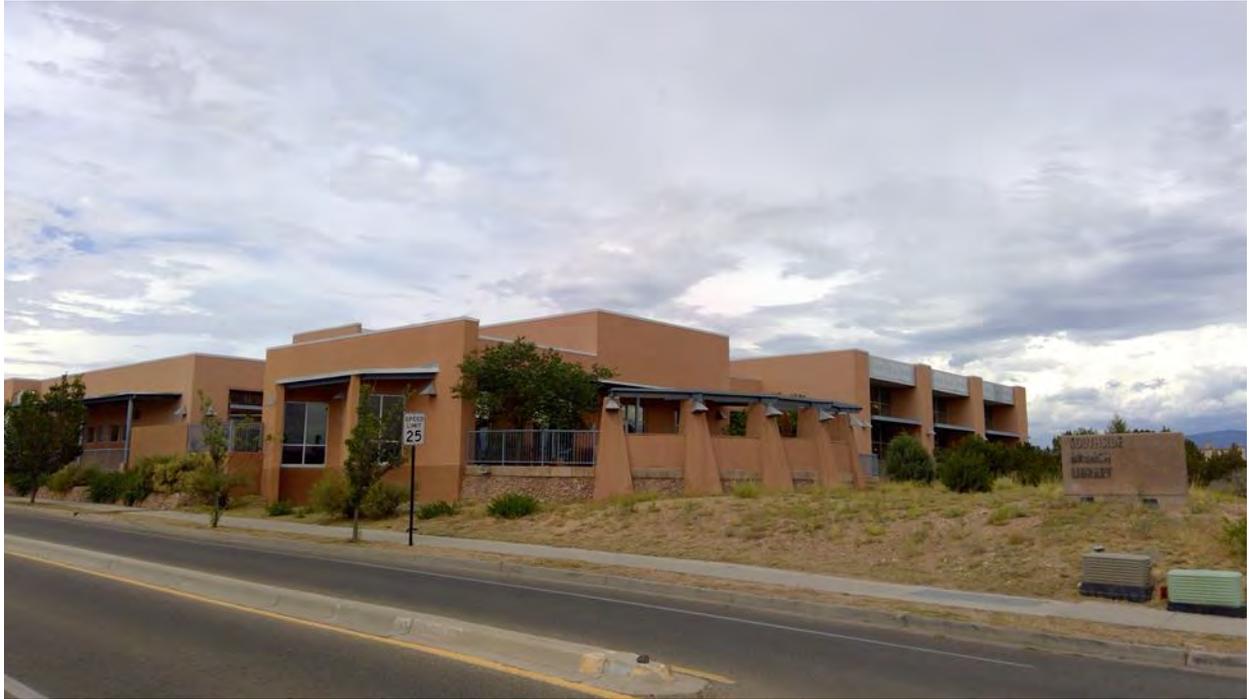
Figure 28: Southside Library Exterior

There are two types of a roof on this building. Firstly, a flat built-up roof that covers the majority of the roof with a 60-mil adhered EPDM roof system supported by metal deck and steel joist. There are multiple punctures in the membrane and deteriorating patches with unknown material. It is apparent with the amount of patchwork present that the library has experienced leaks. These repairs have most likely voided the original manufacturer warranty. The second is a sloped corrugated metal roof, located above the entrance and portions of the elevated roof in the center of the building.

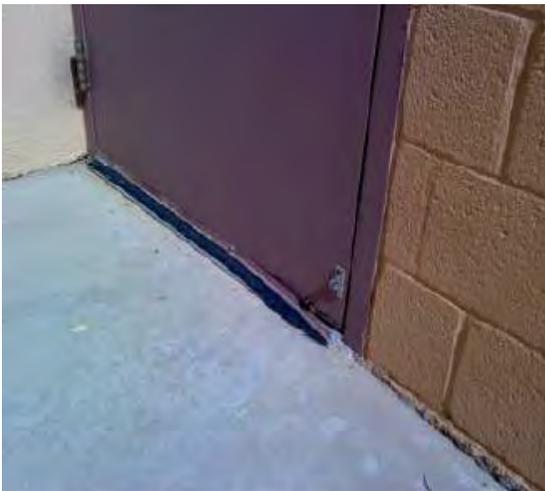
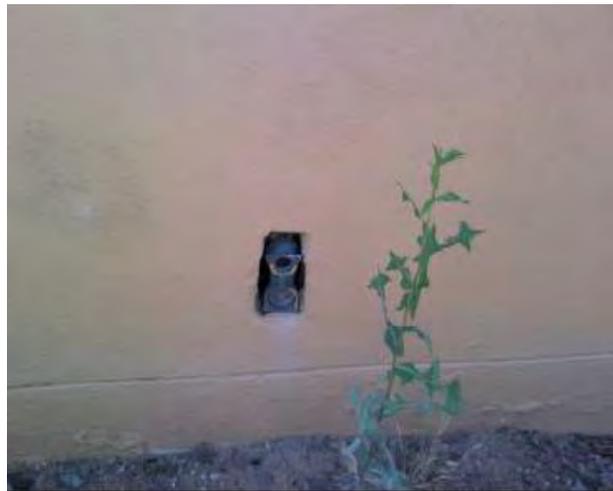
Figure 32: Building envelope issues at Salvador Perez Swimming Pool

Both the upper roof above the natatorium and lower roof above the lobby and offices are constructed with metal roof deck supported by steel joist and batt insulation in the ceiling space with a built-up roof with exterior TPO. The exterior walls are concrete masonry unit (CMU) blocks with split face or brown stucco and interior furred out sheetrock walls. The majority of windows throughout the building are double paned with an aluminum frame on the exterior and interior. There is a glass block section below the windows around the lobby. The main entrance on the west side of the building is through a set of double doors with windows. The southside entrance to the pool is via similar double doors with windows and auxiliary entrances located around the building are single doors made of wood or metal. The largest area of infiltration/exfiltration is at the doors on all sides of the building. These doors would benefit from new weather-strip and door sweeps that would reduce energy consumption. Several penetrations and blank openings are located around the perimeter walls and sealing these would reduce air infiltration/exfiltration and energy loss.

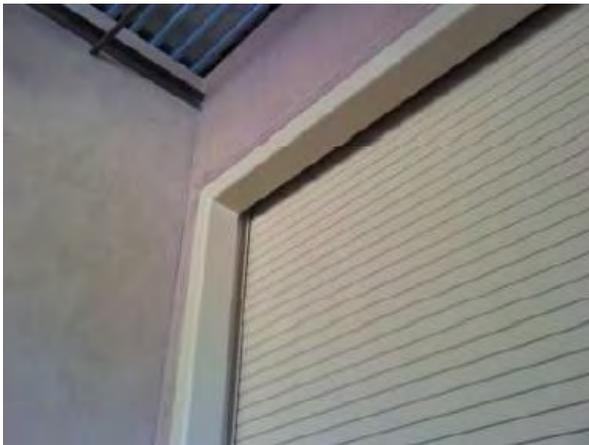
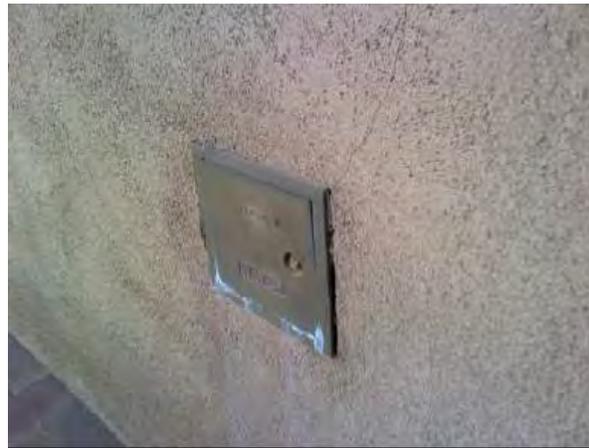
Figure 35: Building Envelope Gaps at SFCC

The roofs are flat and structurally supported by metal deck over steel joist with batt insulation in the ceiling space and built-up roof with TPO exterior. The exterior walls are most likely 6” steel studs at 16” on center, filled with batt insulation, a dark tan stucco exterior, and sheetrock or gypsum board interior. The majority of windows throughout the building are double paned with various color frames. Located around the building are several large public entrances through multiple doors with large window sections. Auxiliary entrances located around the building have single doors made of wood or metal. Located on the loading dock in the back of the building are large Metal roll-up doors. The largest area of infiltration/exfiltration is at the doors on all sides of the building. These doors would benefit from new weather-strip and door sweeps that would reduce energy consumption. Several penetrations and blank openings are located around the perimeter walls and sealing these would reduce air infiltration/exfiltration and energy loss.

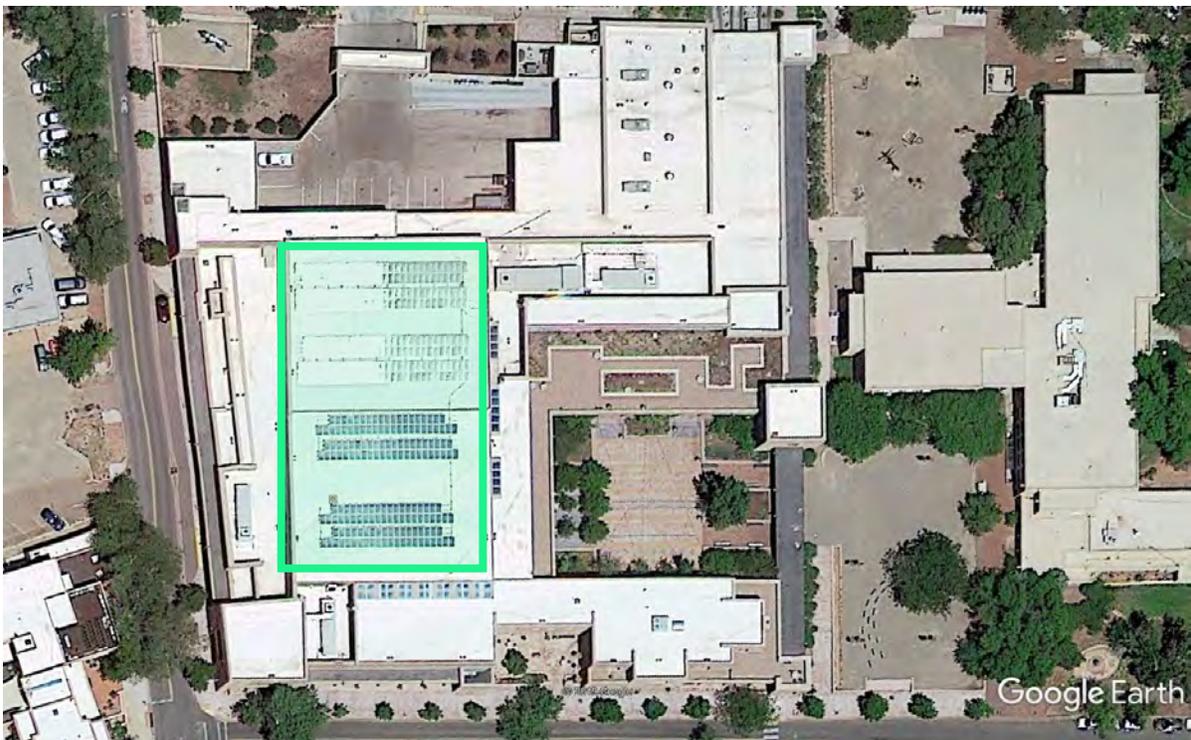
Figure 36: Solar PV System installed at SFCC

The city entered a power purchase agreement (PPA) with Dissigno Holdings that installed a roof-mounted solar PV system. According to staff, there are occasional inverters that fail and go of the line that reduces the system production. Additional information regarding rate and production is available in the Baseline Utility Analysis section of this report.

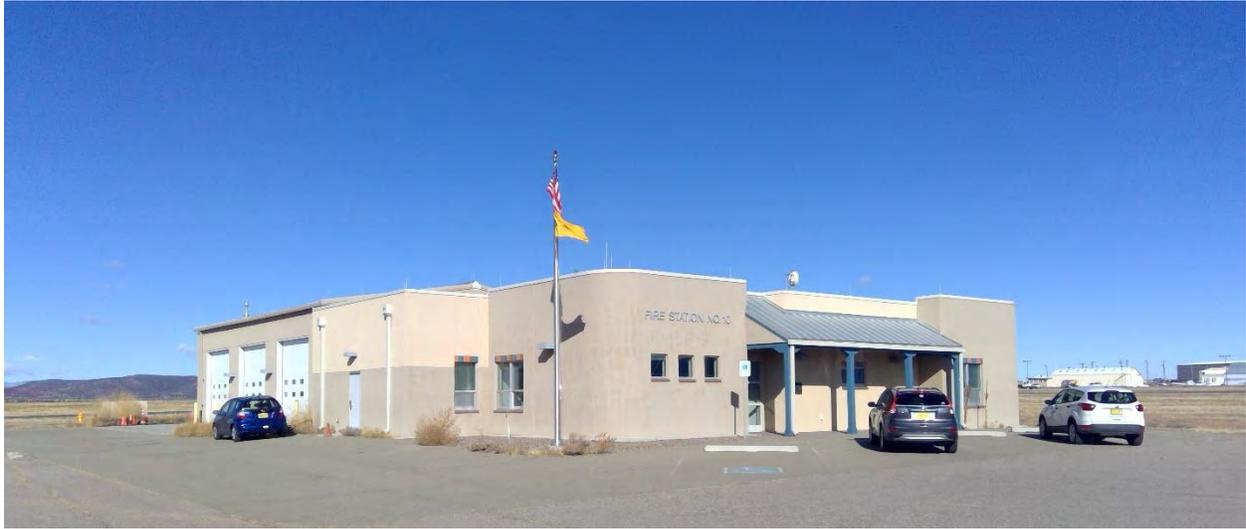
Figure 39: Santa Fe Regional Airport Fire Station

The roof is supported by steel joist and metal deck above the garage and built-up roof over metal deck above the living area. The exterior walls are most likely 6" metal studs at 16" on center, filled with batt insulation, a stucco exterior, and sheetrock interior. The windows and entrance doors with windows of this building are double paned with metal frame. There three large metal garage roll-up doors on both the north and south of the building where the fire trucks and ambulance are located. The largest area of infiltration/exfiltration is at the doors on all sides of the building. These doors would benefit from new weather-strip and door sweeps that would reduce energy consumption. Several penetrations and blank openings are located around the perimeter walls and sealing these would reduce air infiltration/exfiltration and energy loss.

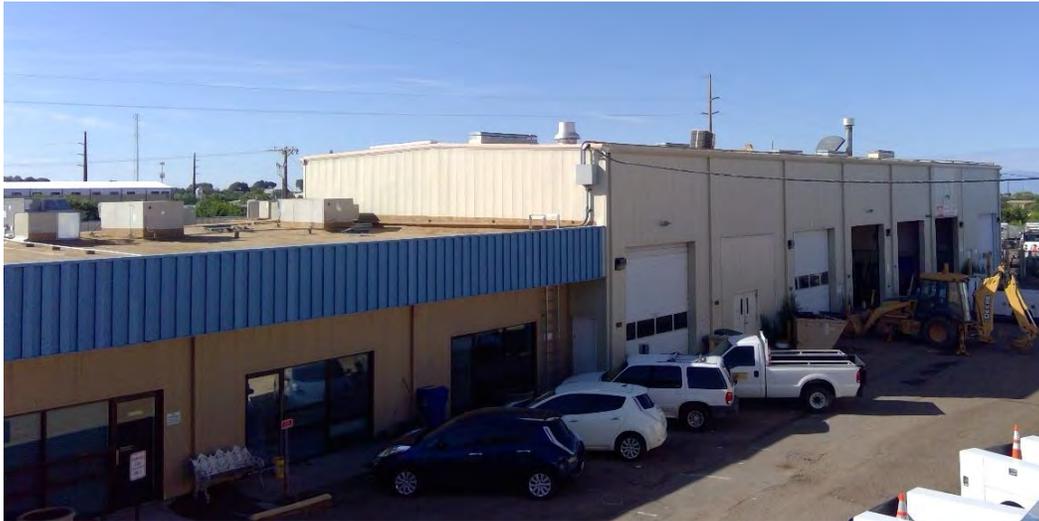
Figure 43: Siler Complex Building C Building Exterior

The exterior office walls have a tan stucco exterior while the taller garage walls are constructed from a light tan metal and furred out sheetrock interior with batt insulation. The majority of windows throughout the building are double paned. Entrance and additional auxiliary doors located around the building are single doors made of wood or metal. There are a number of large metal roll-up doors located at the garage bays. The largest area of infiltration/exfiltration is at the perimeter doors. These doors would benefit from new weather-strip and door sweeps that would reduce energy consumption. Several penetrations and blank openings are located around the perimeter walls and sealing these would reduce air infiltration/exfiltration and energy loss. Several windows on Building A have ineffective sealant and would also benefit from resealing.

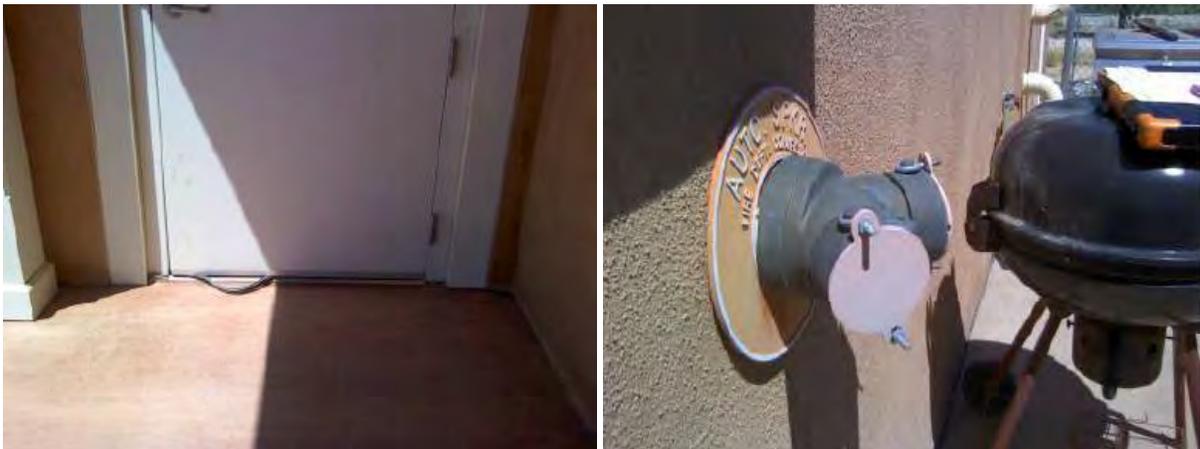
Figure 65: Gaps in Building Envelope at BDD Main

The roof was not accessed at the time of visit but is flat with what appears to be a TPO exterior supported by steel joists with metal decking and batt insulation in the ceiling space. The exterior walls are 2"x6" metal at 16" on center, filled with batt insulation, covered with a tan stucco exterior, and sheet rocked interior. The majority of windows throughout the building are double paned, including a large window wall at the entrance. The main entrance on the east side of the building is through a set of metal double-doors with windows. An additional metal door with windows is located on the west side. Auxiliary entrances located around the building are single doors made of wood or metal. The largest area of infiltration/exfiltration is at the doors on the building perimeter. These doors would benefit from new weather-strip and door sweeps that would reduce energy consumption. Sealing several penetrations around the perimeter walls would reduce air infiltration/exfiltration and energy loss.

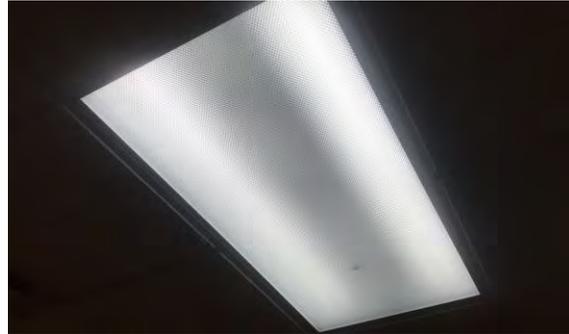
T8 Fluorescent Troffers

T8 fluorescent troffers, shown here with a prismatic lens, are by far the most common light fixture in the COSF. They are found in most office space areas. On average, each of these fixtures consumes 87 watts of power.

This measure will retrofit and/or replace the existing interior and exterior incandescent, fluorescent, metal-halide and other lighting equipment with new Light Emitting Diode (LED) technology. This will significantly reduce the energy consumption of the lighting system while also improving security and the working environment. In addition, the proposed solution would standardize the lighting system throughout the facilities, resulting in simplified inventory requirements and reduced maintenance costs and work.

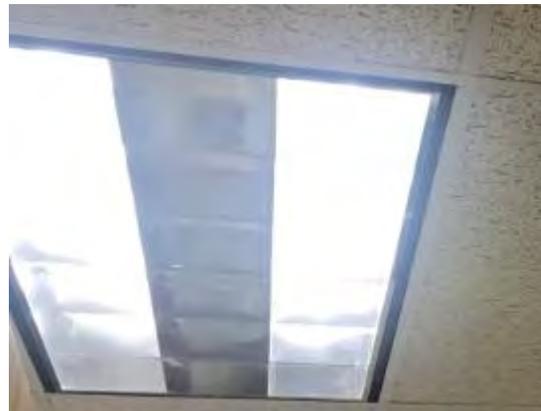
T12 Fluorescent Troffers

While not as widespread as T8s, T12 fluorescent troffers are common within COSF. On average, each of these fixtures consumes 107 watts of power.

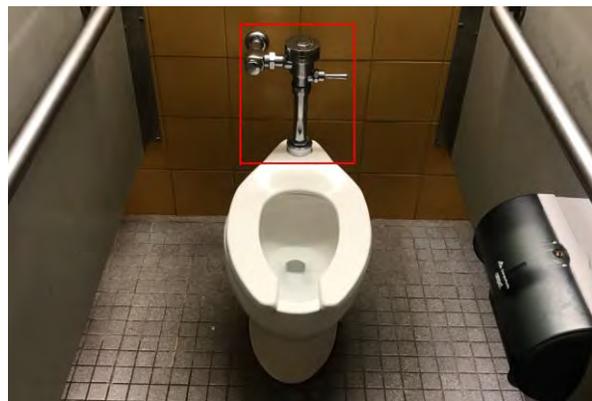
Flushometers like those shown at right are prone to leakage and in many cases have fallen into disrepair, resulting in a release of much more water than is necessary. This measure will rebuild and re-tune flushometer assemblies to combat water waste.

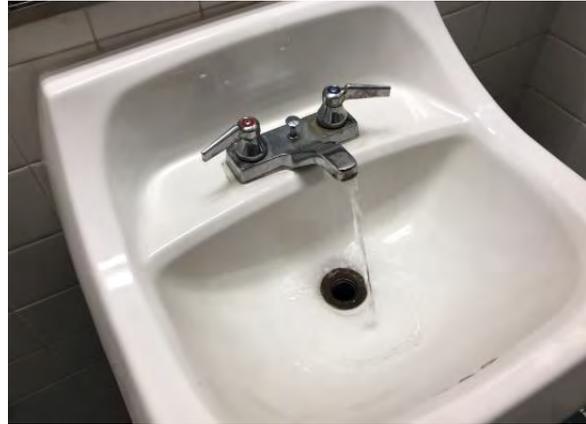
Sink Aerators

This faucet is an example of a fixture whose aerator has either been removed or was never present. Installation of flow control devices will reduce water consumption at these fixtures.

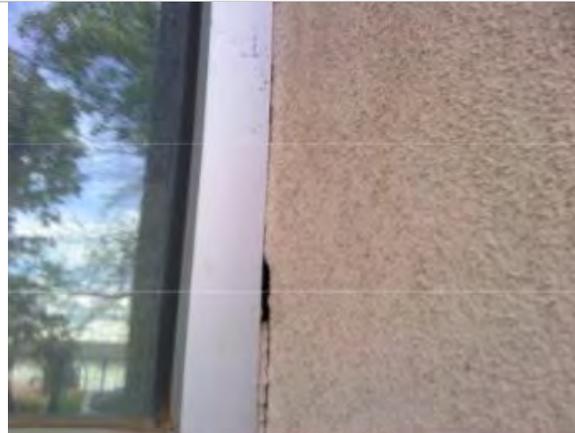
Windows

Gaps at window / wall junction should be sealed as shown at the Siler Complex.

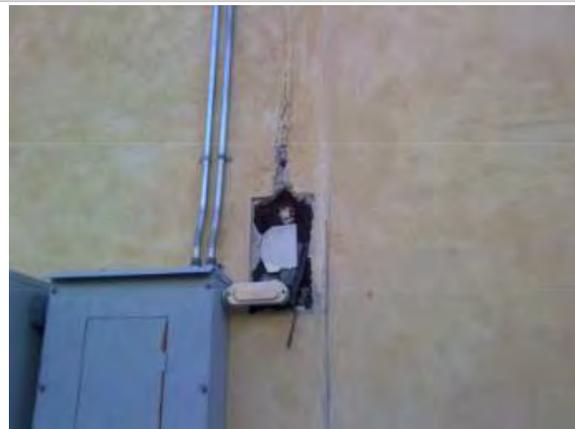
Air Leakage

We recommend sealing penetrations and blank openings to reduce air and moisture infiltration and exfiltration leading to energy loss

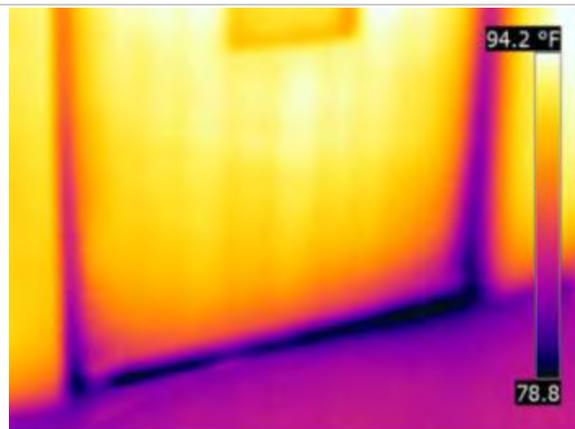
Exterior Doors

The thermal image at right shows a typical example of failed weather-stripping at exterior doors. Here dark blue at the edges of the doors signify a large temperature differential is apparent, signaling severe leakage.

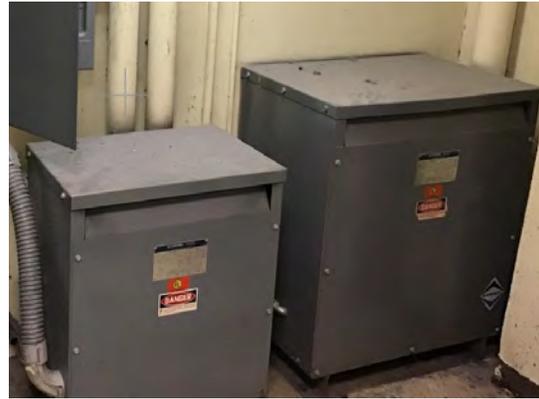
Low-Voltage Transformers

Several transformers like those shown at right are present throughout the electrical rooms in the facilities. Most of these units have been in place since the time of the facility's original construction.

Modifications will include replacement of the existing transformers, shown in Table 109 and Table 110, with new, high-efficiency Powersmiths' model E-Saver-80R transformers. Energy savings are driven by modern, precision-crafted cores and coil windings. Refer to **Appendix H3** for specifications.

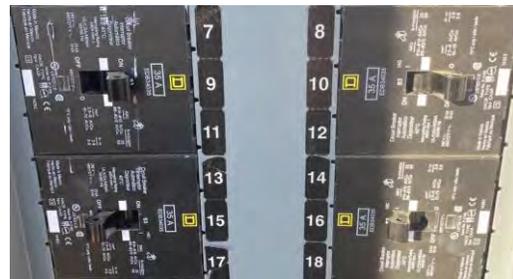
Tripped Breakers

Besides inverter failures, multiple inverters are showing error messages that are limiting the system potential production.

Multiple breakers are tripped, and these have been reset and not able to stay on during higher system production times, reducing the overall system production.

The proposed modifications would repair the system to its original design production and include replacing the existing breaker panels, invertors, and install a remote monitoring system that would allow to validate production.

1. Replace all 26 existing inverters with 26 Chint Power Systems 23kW AC inverters with Standard 10-Year Warranty.
2. Replace existing 600V wiring with 1000V rated wiring.
3. Install appropriately sized back feed breakers where applicable.
4. Install remote monitoring systems for both PV systems.
5. Existing solar PV modules and carport racking equipment to remain.
6. Perform system commissioning and system optimization tests to ensure the solar system will produce energy as intended as follows:

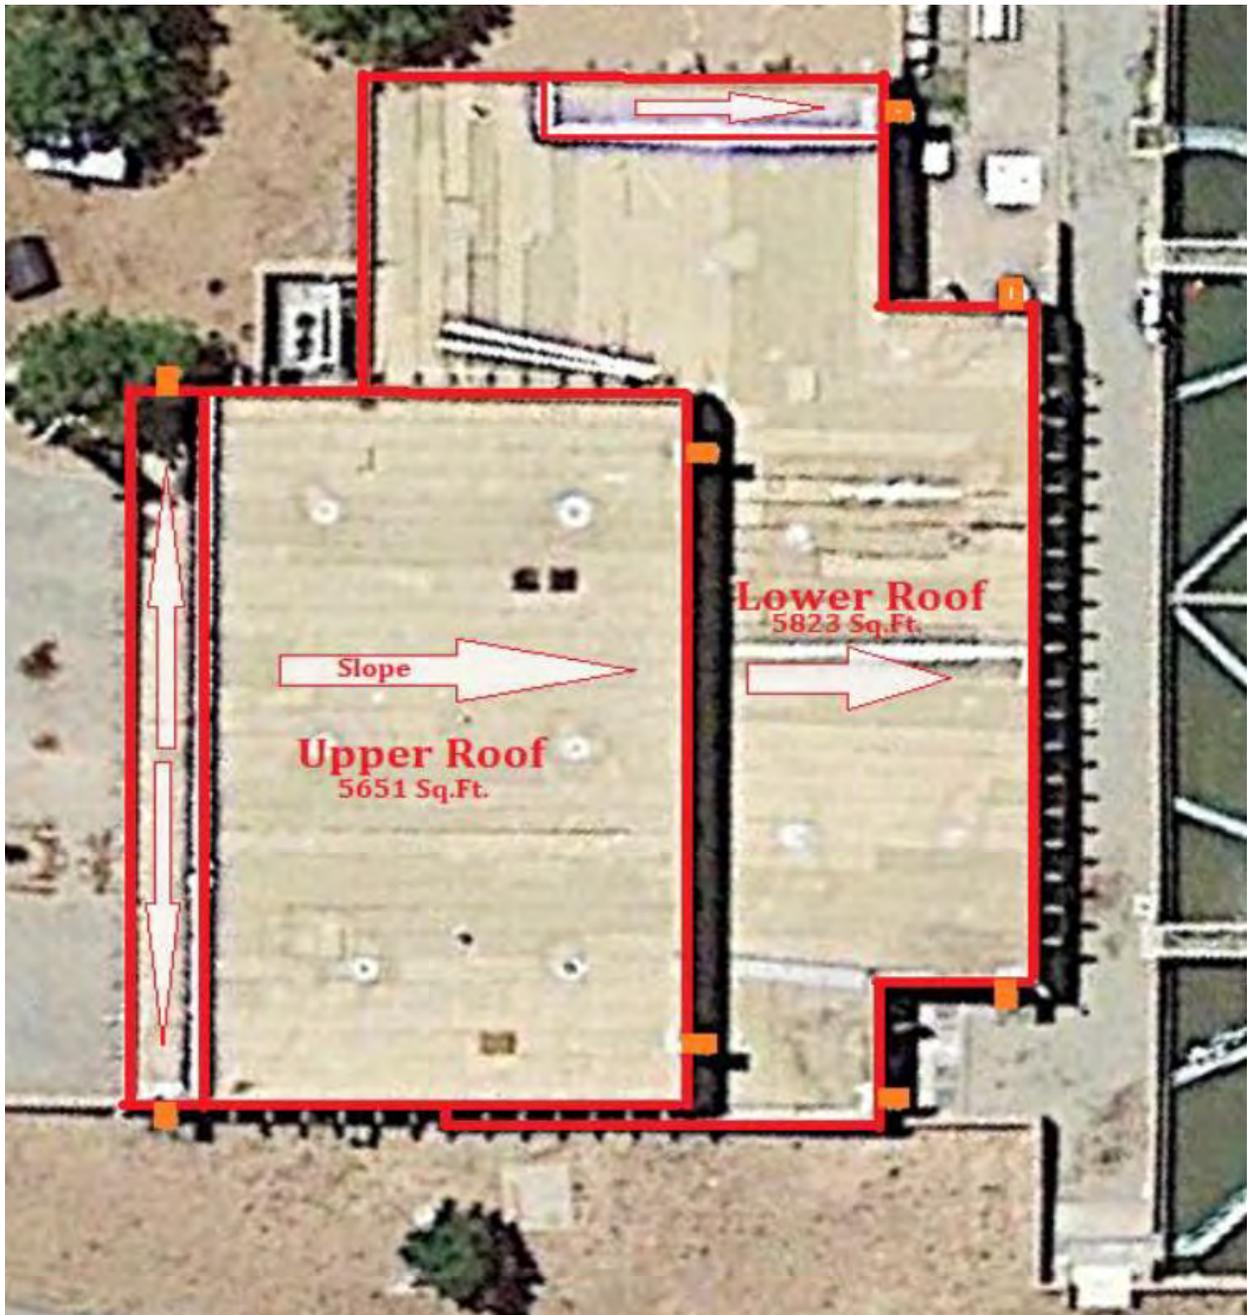
Figure 77: Canyon Road Water Treatment Plant Roof Levels and Aeras

1. 2" polyiso roof insulation
2. 3-ply BUR
3. 90# cap sheet
4. Mopped to concrete deck with asphalt

Replacement of the entire Canyon Road WTP Main Building roof surface is recommended due to age-related deterioration noted above. No HVAC equipment or systems are included in the work scope. Should the COSF decide to replace the HFAC equipment at this facility in the future, YE recommends that the engineer of record perform the load calculations to properly size the equipment based on conditions at that time.

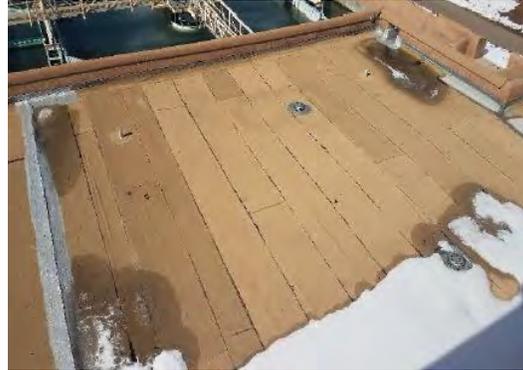
South Low Roof

The photo at right shows evidence of severe weathering on the roof material.

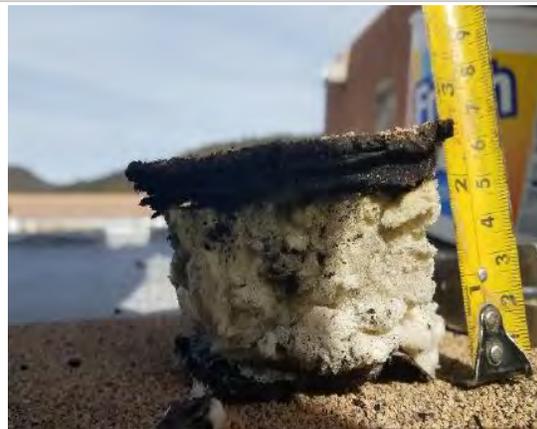
Low Roof Core Drill

Roof core, low roof section, showing 2" Polyiso, 3ply BUR, Cap sheet, hot asphalt.
